Case Study

Structural performance of URM school buildings during the 2019 Albania earthquakes

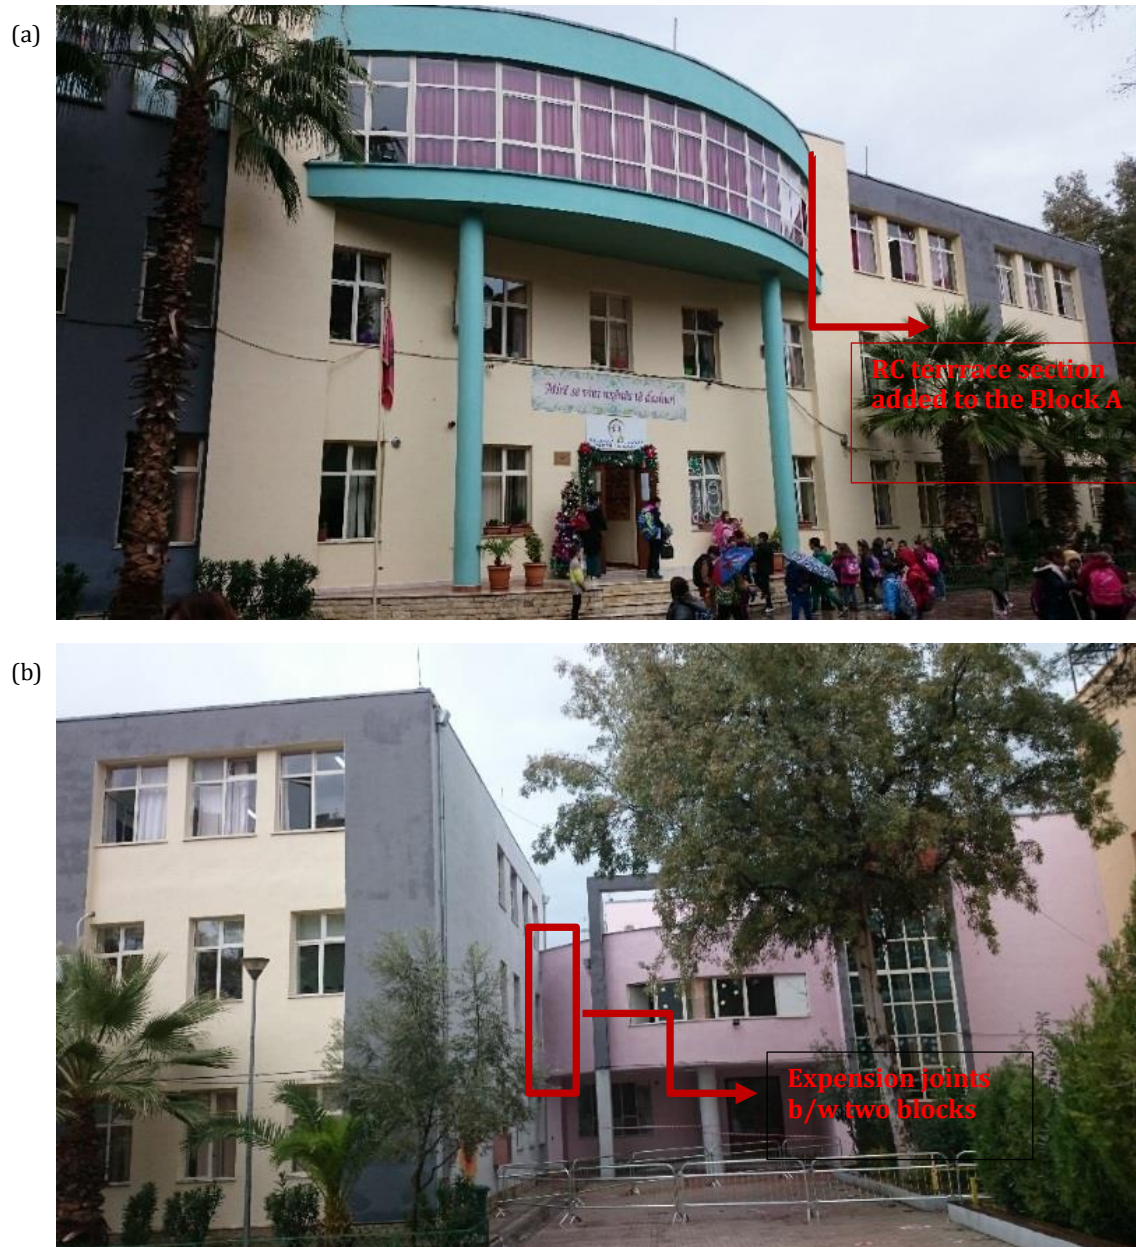
Fig. 7. a) Front view of A Block; b) Front view of B Block and its intersection with A Block.

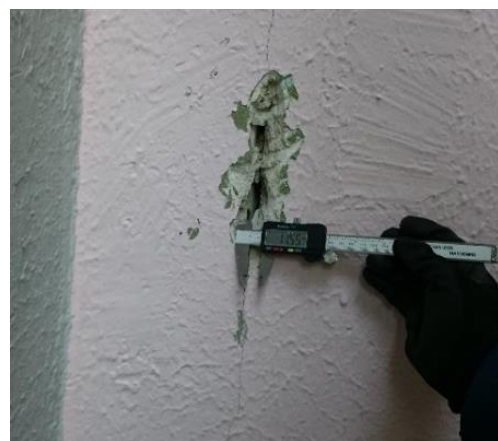
The expansion joint in the junction area of the old masonry structure (Block A) with the later added Block B structure is insufficient (Fig. 8).

Fig. 8. Expansion joint between two buildings (11.55 mm < 30.00 mm).

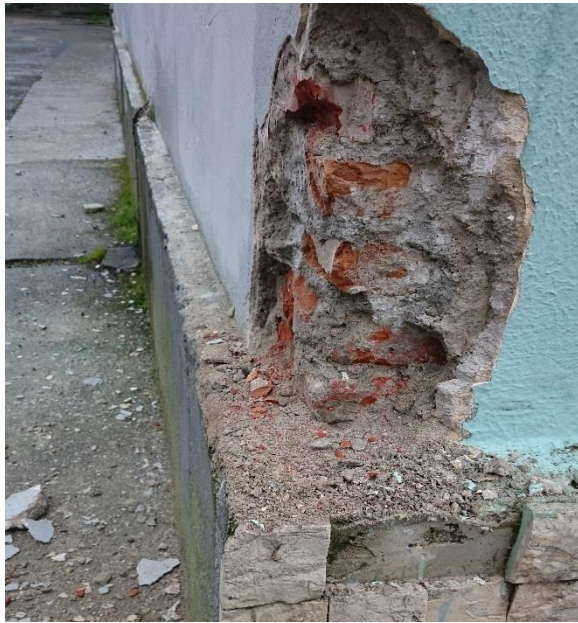
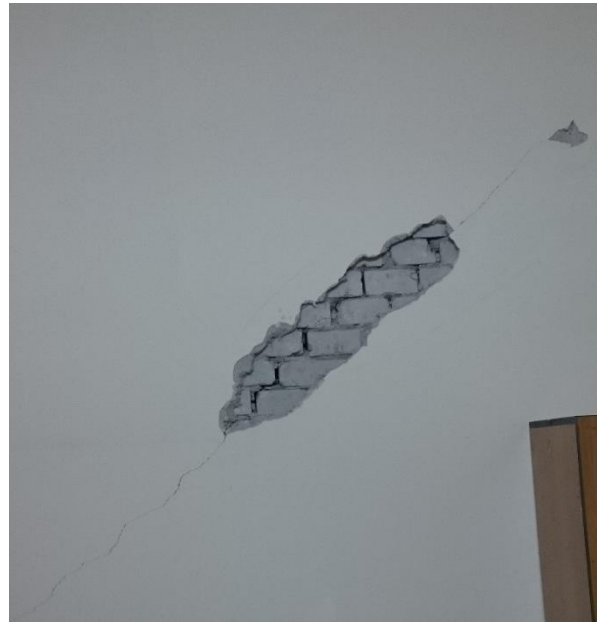
In order to determine the type of wall material used in the masonry structures and the way the walls were built in the corner area, the cover layer was removed (Fig. 10). Lime mortar and solid clay bricks were used for wall construction in Block A and silicate bricks were used in Block B.

a) Block A- Clay bricks

b) Block B- Silicate masonry

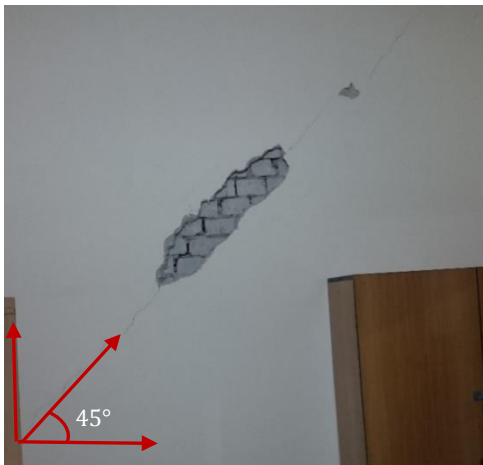
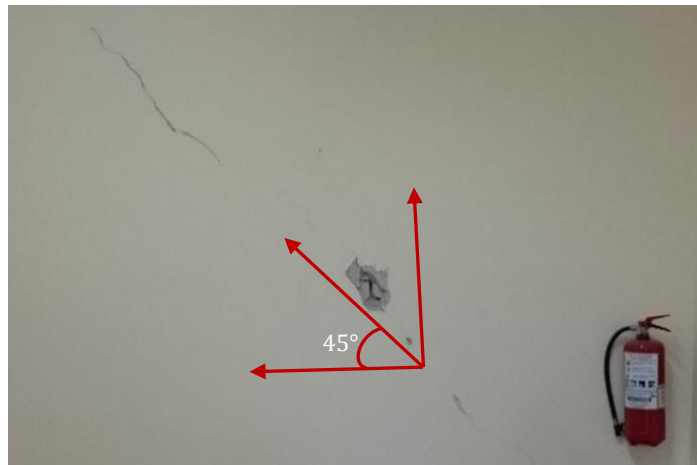
During the inspection inside the buildings, a considerable damage was observed on Block B. We observed a 45° inclined shear crack on a number of walls on the ground floor (Fig. 11). This structural crack was formed on the 45 cm thick wall, which was subsequently removed in the upper floors to make additional space, during the Durrës earthquake of 26 November 2019.

**Fig. 11.** Shear cracks on load bearing walls in the ground floor of the Block B.

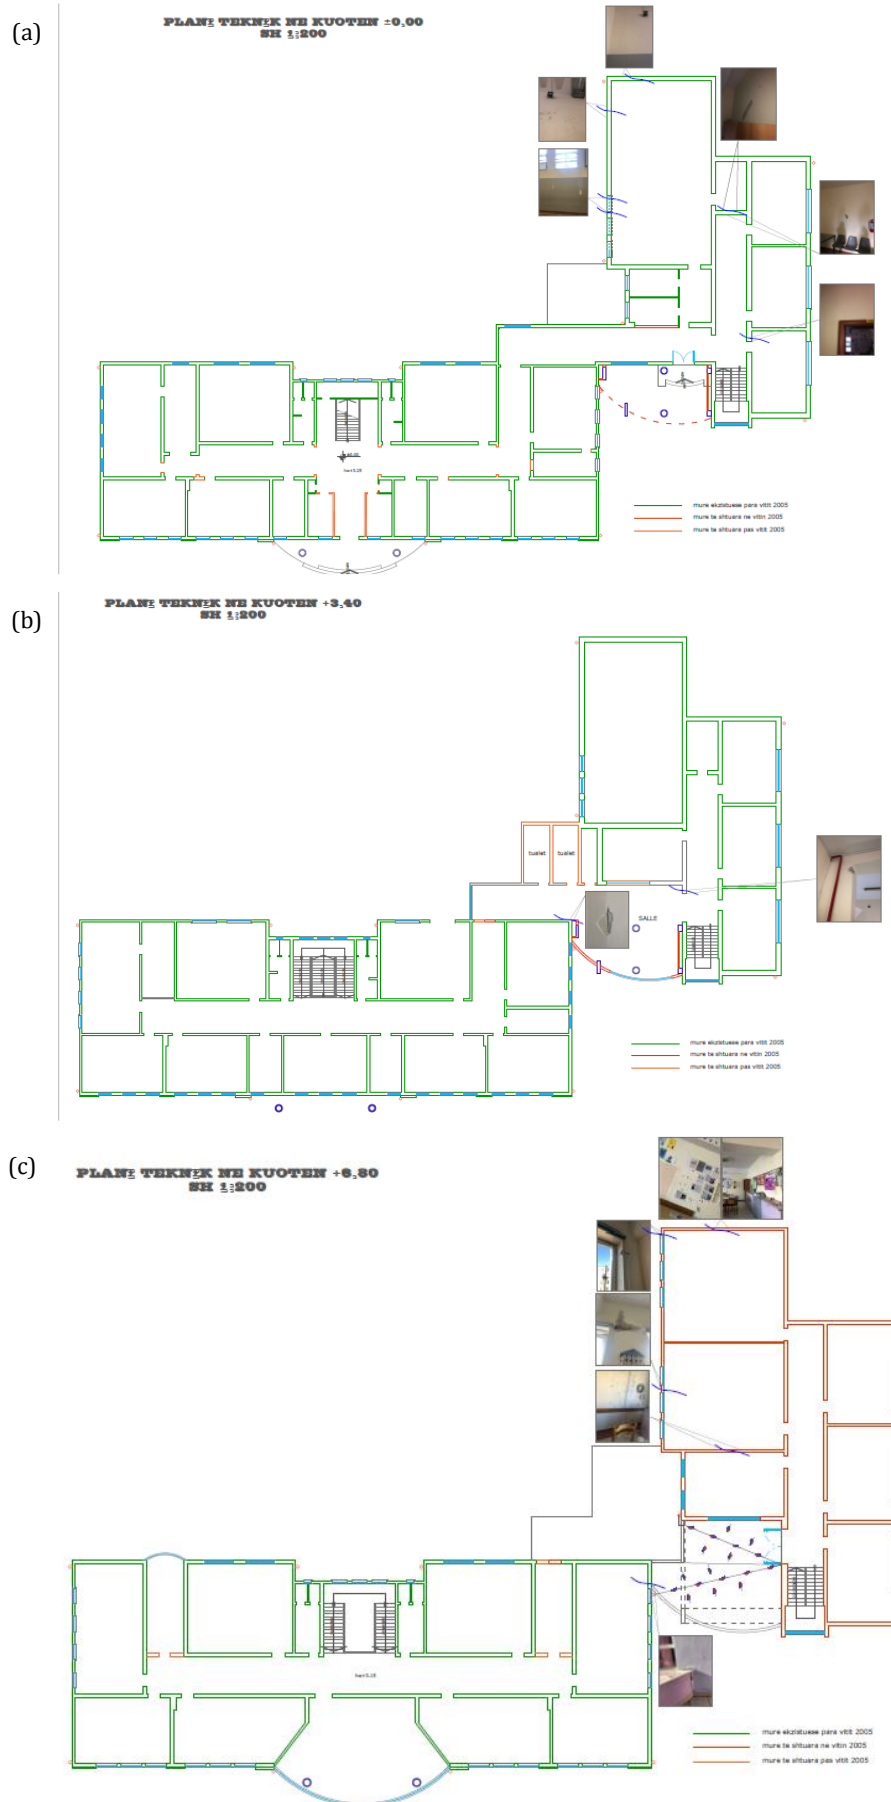
Fig. 12. a) Slight-moderate damaged locations on the ground floor; b) Slight-moderate damaged location on the 1st floor; c) Moderate-severe damaged locations on the 2nd floor of the Block B (This floor was added lately and made the building more vulnerable during 26 November earthquake).

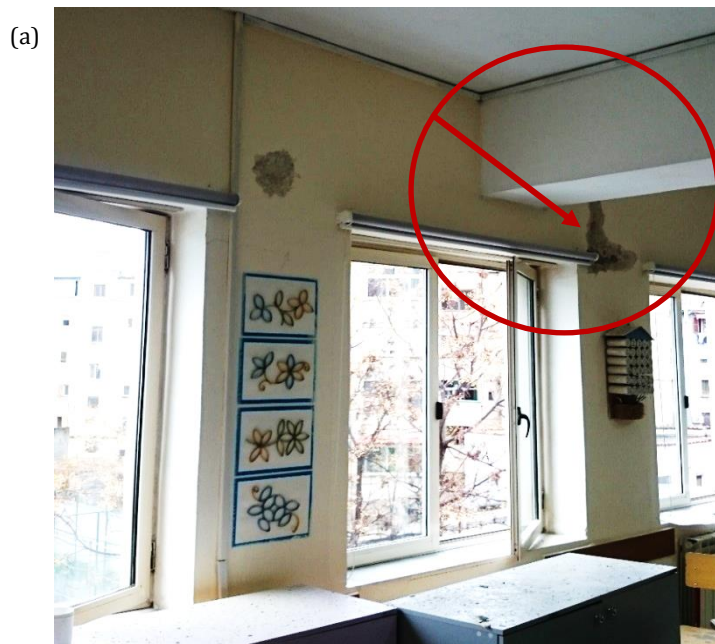
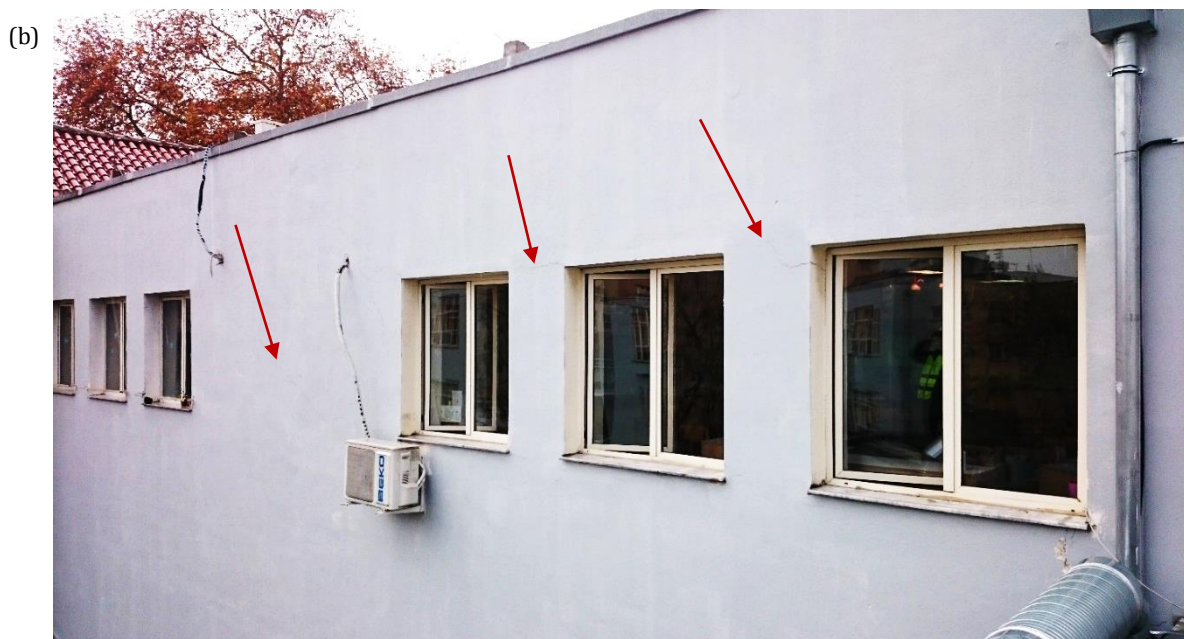
On the last floor, it was observed that the beams were located on the spandrels in the middle of the windows

(Fig. 13). During the earthquake, this caused serious damage in the inner and outer part of the connecting areas. They should have been cast on the pier elements to safely convey the slab and roof loads to the foundation.

Fig. 13. a) A beam casted on spandrel over a window in the last floor of Block B and caused serious damage; b) Diagonal shear cracks on outer façade of the last story. This damage patterns also continue in the inner part.
