## Strengthening and performance assessing historical cinema hall balcony according to new Turkish Earthquake Code

Fig. 1. Views of Zonguldak historical theater hall (1965).

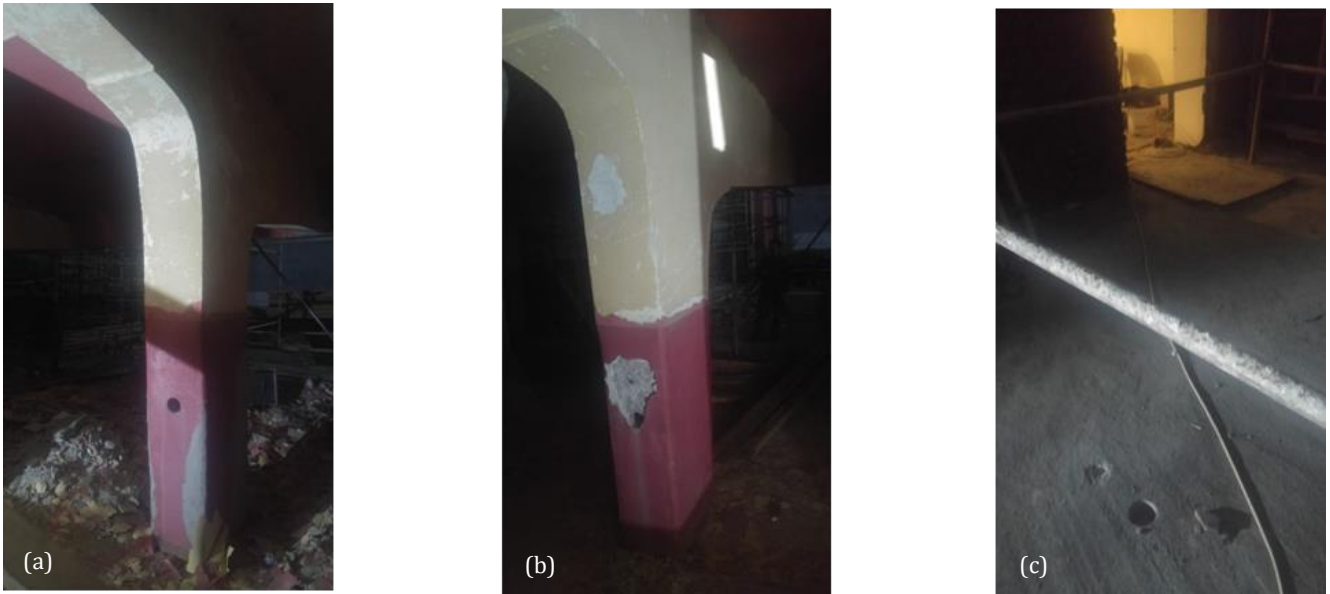
In this study, core samples were taken from the carrier elements of the building and the balcony floor. Due to the fact that the building is a historical building, care was taken not to damage the historical artifact while taking the core sample. Three samples were taken from each carrier and these samples were subjected to pressure testing in the laboratory (Fig. 4). According to the pressure test results, in some of the balcony main columns (S39, S40, S41, S42), concrete class has been determined as C14 and all other carriers have been determined as concrete class C18. Then all the carrier elements were scanned with an x-ray device and the current state of the reinforcements in it was determined (Fig. 5). It was determined that most of the reinforcements were corroded and it was observed that melts and explosions occurred in the reinforcements over time in both main bearing columns of the balcony. After

**Fig. 4.** Core samples taken from the structure: (a) Main column S41; (b) Main column S42; (c) Balcony flooring.

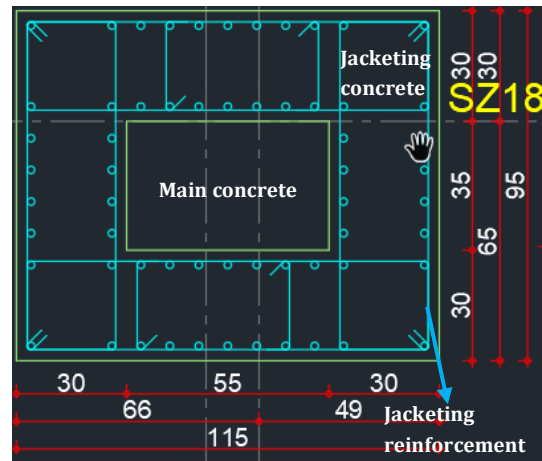
Fig. 10. Jacketing detail of S41 column.

short time. The carrier elements detected later were reinforced with jacketing. A total of 4 columns on the ground floor and 4 columns on the first floor were jacketed. The jacket thickness is 20 cm and C25 concrete was used when jacketing. A total of 4 columns and 3 balcony beams were examined both before and after reinforcement and presented in this section. These columns and beams are presented in Fig. 11. In this study, balcony columns and beams were evaluated for G+Q+E (X and Y) combinations according to 2018 earthquake regulation. These standard combinations were used to obtain the most critical condition of the historical building during the earthquake. These combinations show the situation in which the structure receives the greatest moment and shear forces. Therefore, these combinations were used in this study.

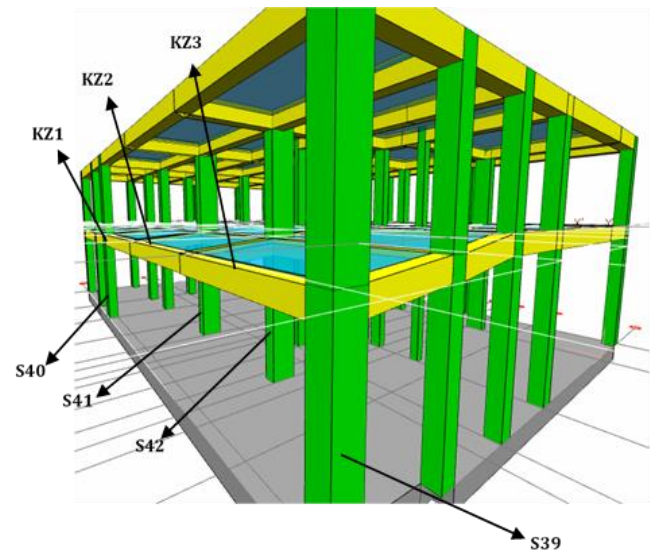
**Fig. 11.** The most critical sections for the current situation of the building.

It was determined as a result of on-site examinations that the explosions occurred in S39 column over time. According to performance analysis results, it was observed that the greatest moments and forces occurred in this column. The greatest normal force occurred in S39 column is -26.21kN in *i* direction and -10.23 kN in *j* direction. In addition, the largest shear force took place in this column is -5.58 kN in *i* direction and -2.98 kN in *j* direction, and these forces occurred in G+Q+EY combination. The biggest moments in this column are 11.33 kNm in *i* direction and -5.89 kNm in *j* direction (Table 2).

When these values are evaluated, it is observed that larger loads and moments occurred in the S39 column when compared with S40 column and it was observed that more damage occurred in the S39 column.

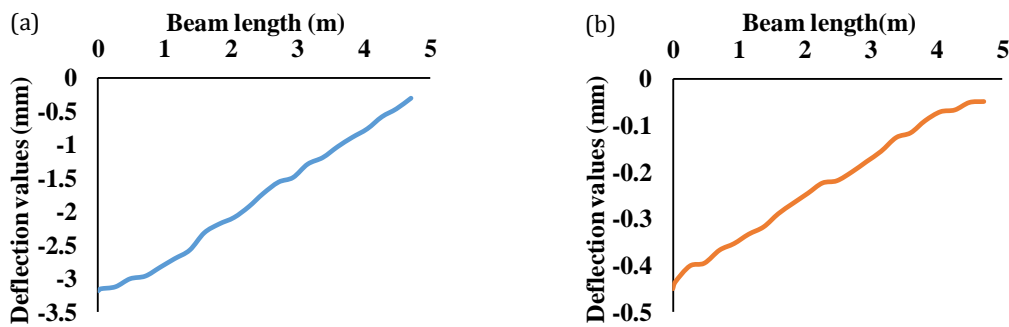
kN and the biggest shear force in *j* direction is 4.61 kN. The maximum moment values in *i* and *j* directions are 0.92 kNm and -7.17 kNm, respectively. Also, the deflection behavior of this beam under G and Q loads is shown in Fig. 12. Under G loading, deflection value at 0 m is -3.37 mm and at 4.5 m deflection value is -0.45 mm. The biggest deflection value in the beam under Q loading is -0.45 mm (Fig. 12).

**Fig. 12.** Deflection values for KZ1 beam: (a) Under G loading; (b) Under Q loading.

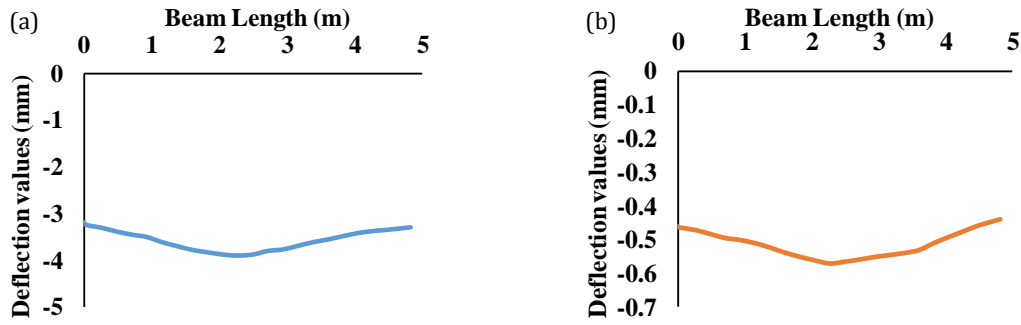
occurred right in the middle of the beam and the deflection value is -0.61 mm. Finally, when the KZ3 beam is examined, it is seen that the largest shear force values in *i* and *j* directions are -2.07 kN and 1.88 kN, respectively (Table 7). In addition, the largest moment values in *i* and *j* directions were determined to be -1.33 kNm and -0.48 kNm. In Fig. 14, the biggest deflection values of the KZ3 beam under G and Q loads are presented. The largest deflection obtained in beam under G loading is -3.4 mm and this value occurred at the ends of the beam. The biggest deflection value acquired in the beam under Q loading is -0.46 mm.

Fig. 13. Deflection values for KZ2 beam: (a) Under G loading; (b) Under Q loading.

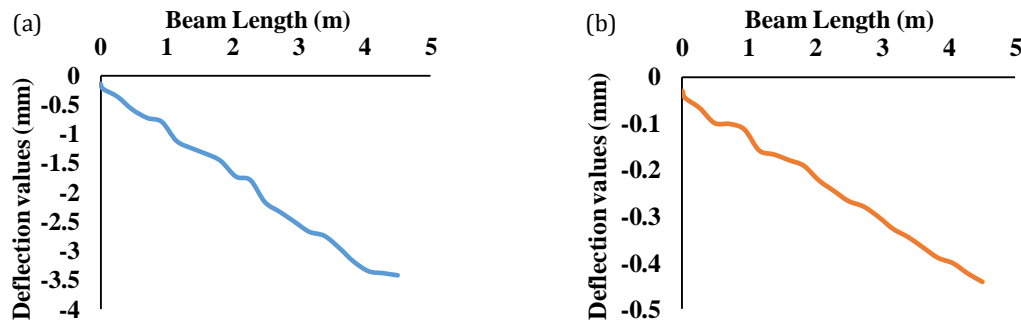
Fig. 14. Deflection values for KZ3 beam: (a) Under G loading; (b) Under Q loading.

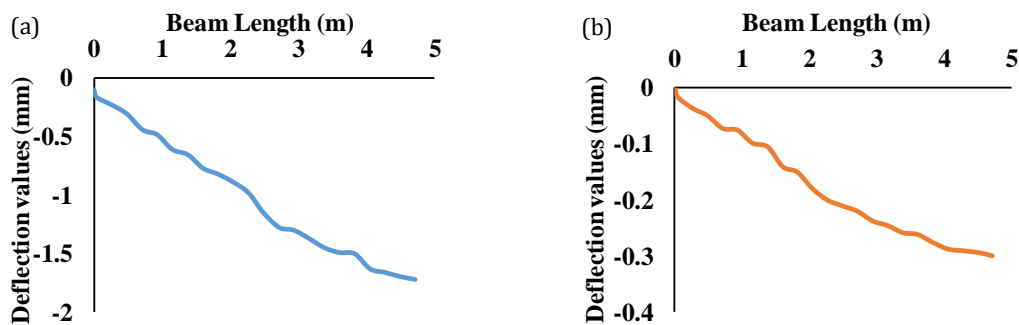
place in the beam under G and Q loading are presented graphically. Under G loading, deflection value of -0.1 mm occurred in the beam at 0 m. However, deflection of -1.61 mm took place at the end of the beam (4.7 m) (Fig. 15a). Under Q loading, the maximum deflection occurred at the ends of the beam and its value is -0.27 mm (Fig. 15b).

**Fig. 15.** Deflection values for KZ1 beam: (a) Under G loading; (b) Under Q loading.

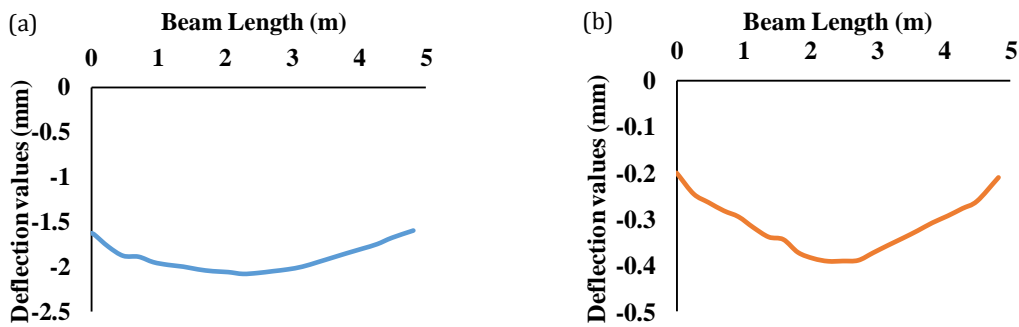
beam are presented in Fig. 16. According to Fig. 16, maximum deflection took place in the middle parts of the beam under G loading and its numerical value is -2.12 mm. Under Q loading, the maximum deflection is similarly observed in the middle parts of the beam and its numerical value is -0.4 mm.

**Fig. 16.** Deflection values for KZ2 beam: (a) Under G loading; (b) Under Q loading.

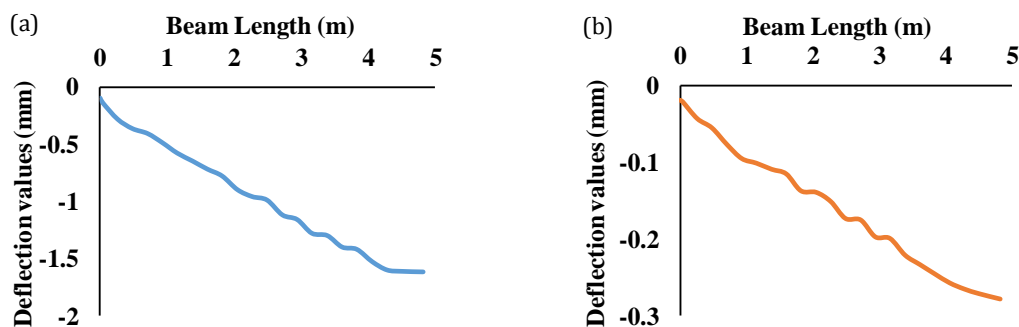
beam and its value is -1.58 mm. In addition, the biggest deflection value for Q loading is -0.28 mm. In addition, in Table 15, deflection values occurred in beams before and after reinforcement were compared and tabulated. As can be seen from Table 15, earthquake reinforcement in historical buildings reduces deflection values in beams.

**Fig. 17.** Deflection values for KZ3 beam: (a) Under G loading; (b) Under Q loading.
