Case Study

Cause of distress of an old building through analytical and micro-analytical methods – a case study

^a Indira Gandhi Centre for Atomic Research, 603102 Kalpakkam, Tamilnadu, India

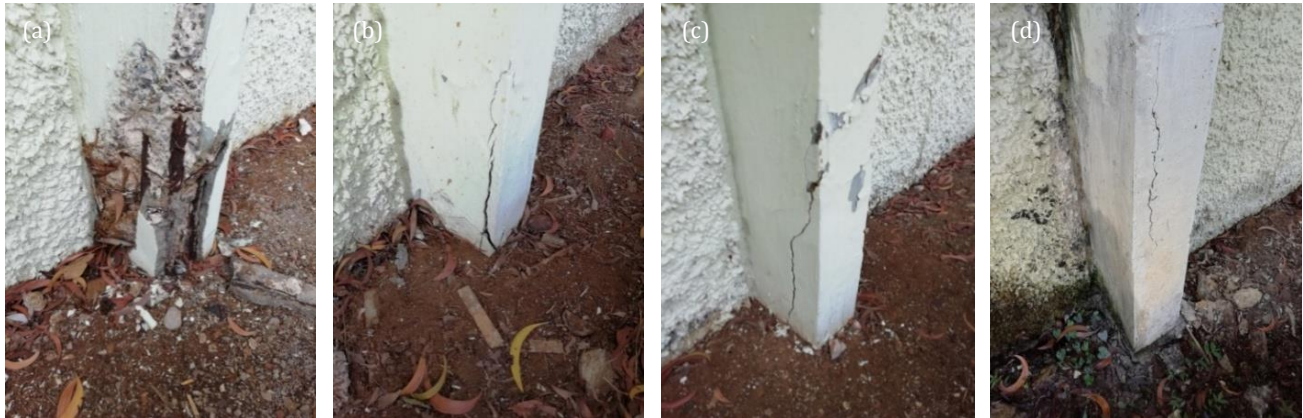
Fig. 2. Spallation of columns: a) C1; b) C2; c) C3; d) C4.

The cracks which lead to spallation were more than 2-3 mm and length of 400 mm, whereas hairline cracks of the order of 0.5 mm were also visible. However, initially, cracking and spallation appeared to be due to corrosion, aspect of overloading or settlement of the founding medium etc. could not be overruled. The soil reports from recent adjacent construction site were useful in overrul-

Though cracking was not visible at first, except for in few columns in the southern block, close inspection revealed hairline cracks and also signs of repairs previously carried out in several columns. Except for the south block, plinth protection and drain covered the columns all around the periphery. The south block columns showed distress to a height of 0.8 m from the ground level. Organic soil was observed to cover this particular

height of the column for quite some duration and distress became visible on removing the soil cover. Rough-cast plastered external masonry, though appeared intact outside; cracking was seen at the inner surface. There was visible distress in masonry and window panes associated with the columns. There were no evident signs of distress in the internal beams and columns.

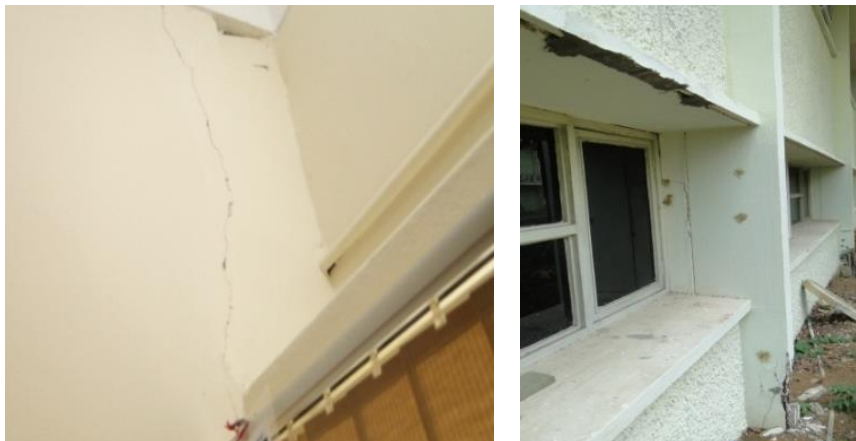
Fig. 3. Cracks in masonry and sunshades.

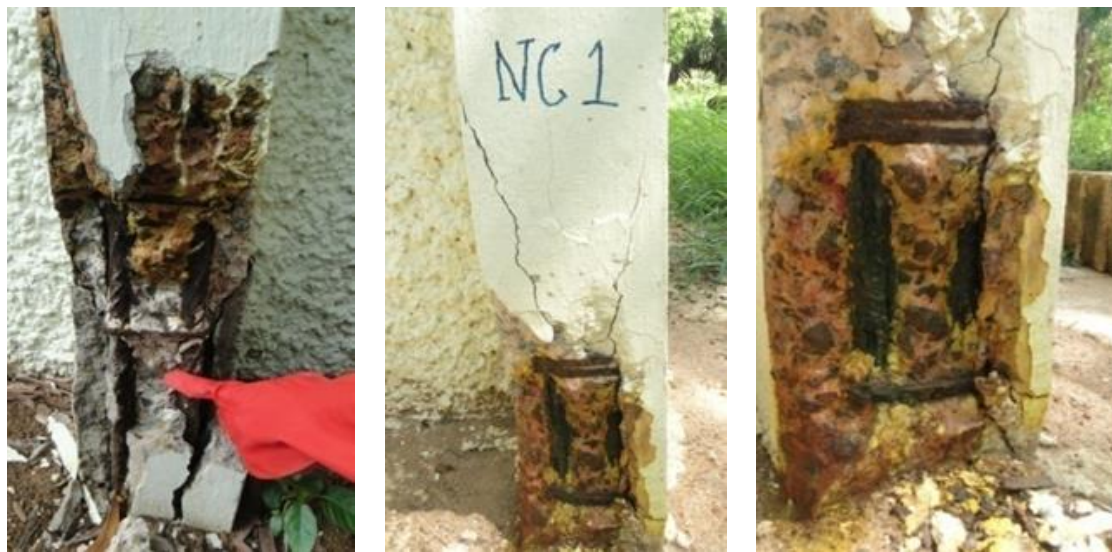
A colorimetric method based on Collepardi (1995), by spraying Fluoresceine and a Silver Nitrate solution was used to determine the presence of free and bound chloride and its penetration into the concrete structure as it has been generally assumed that free chloride ions can promote the corrosion process of steel reinforcement. In brief, the investigation was carried out at the fractured surfaces of the structure by spraying the Fluoresceine solution (1g/L in a 70% solution of ethyl alcohol in water) followed by Silver Nitrate (0.1mol/l) aqueous solution. A dark pink coloration indicated presence of free chloride areas and a dark brown coloration indicated bound chloride zone on the grey concrete (Fig. 6). This process was also adopted on a fractured core sample extracted from the structure, wherein the depth of free chloride penetration was indicated by a color change with a clear demarcation till the region of bound chloride region.

Fig. 6. Colorimetric method to check free and bound chloride on the exposed structural member.

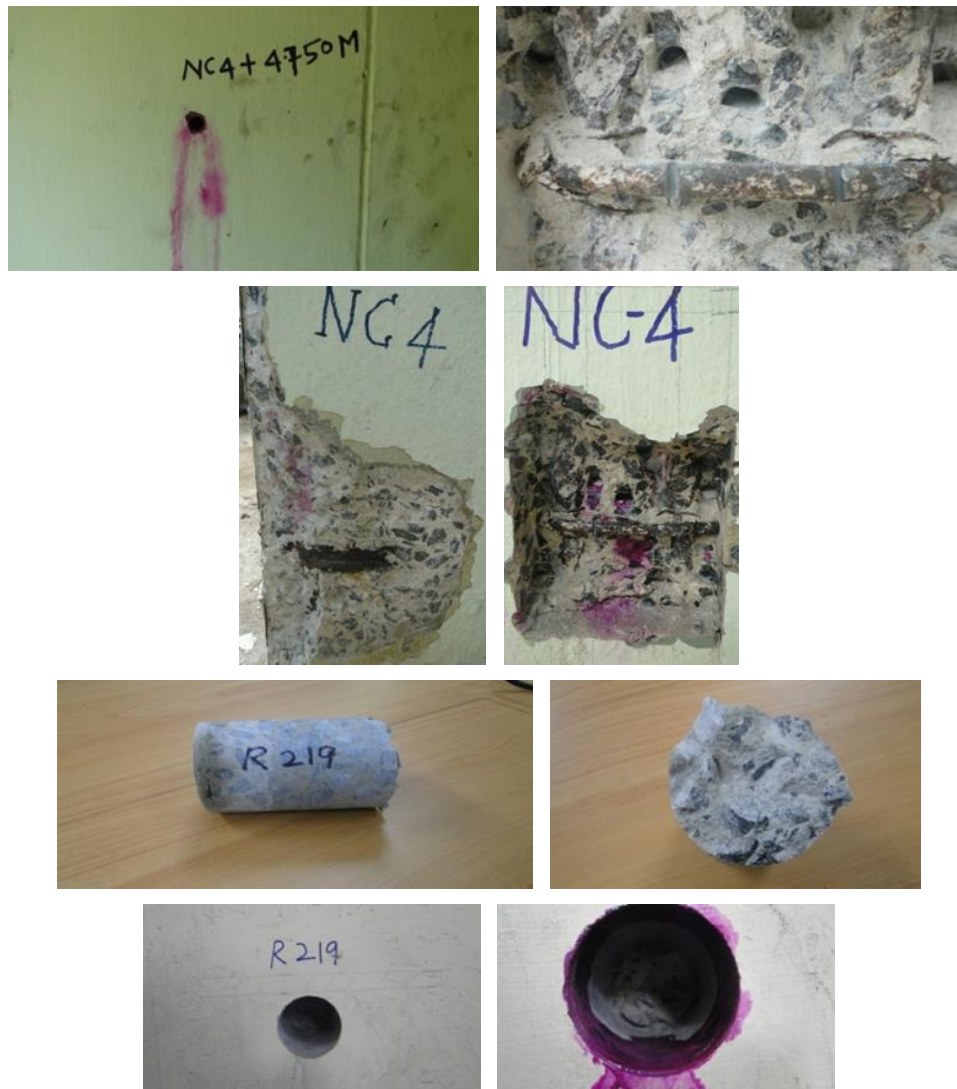
The carbonation test was carried out as per RILEM CPC-18 (1988). The reduction of the pH value could be made visible by applying a 1% phenolphthalein solution to a freshly fractured surface of concrete. The non-carbonated areas turn red or purple while carbonated areas remain colorless. The phenolphthalein solution was sprayed on the freshly cored concrete surface and the color change was observed (Fig. 7).

Fig. 7. Concrete carbonation tests on the fractured structural member, cored member and checking for the corrosion of rebar.

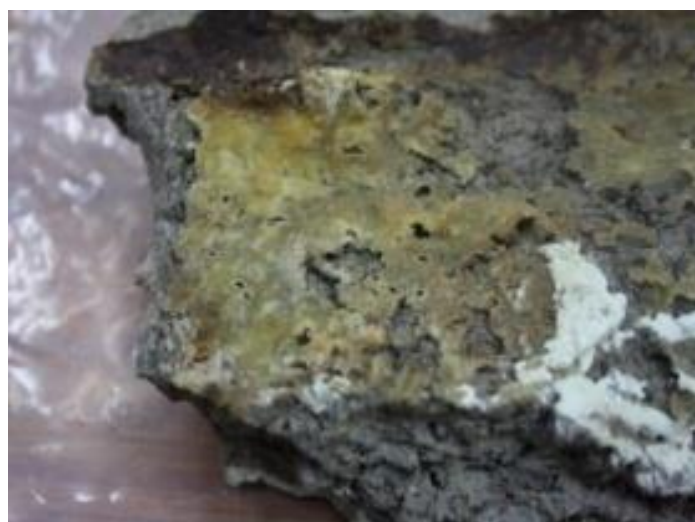
The spalled concrete from C3 column had a pale yellow color deposition (Fig. 8). The deposit was sliced and observed under a light microscope for microscopic structures. Fungal cells in spalled concrete and soil re-

sembled of *Gaeumannomyces* / *Gaeumannomyces* sp. and hyphopodia and also sulphur reducing bacteria. This was confirmed by using the deposit as an inoculum for

microbial enrichment in Saboraud dextrose broth and Luria-Bertani broth. Sulphur was not present in X-Ray fluorescence (XRF) analysis of the deposited sample.

Fig. 8. Biogenic growth at the inner face of the column.

23.5° were seen in the sample of C3 column, having biogenic growth.
