Vertical displacement of collapsed bridge in Palau

Vertical displacement of the Korror-Babeldaop (KB) Bridge in Palau is presented. This bridge was built in 1977 by the cantilever method and collapsed 3 months after remedial prestressing in 1996. KB Bridge was a segmental prestressed concrete girder having the world record of 241 m and maximum girder depth of 14.17 m. The final mid-span deflection was in design expected to be 0.53 to 0.65 m but after 18 years it reached 1.39 m and was still increasing. With a very limited amount of official information of the bridge was available and bridge was analyzed by ANSYS finite element program. Presented is an accurate analysis using 5392 hexahedral three-dimensional (3D) finite elements with 9614 nodes by ANSYS. Hognestad concrete model and Solid 65 element type were considered. The actual vertical displacements of free end of the cantilever bridge under truck loading were compared with the 3D finite element analyses results in order to come up with a benchmark model. The collapse reasons of KB Bridge were discussed.

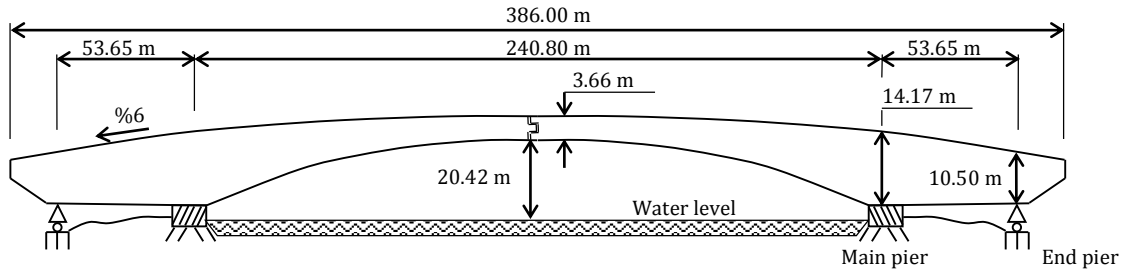
Fig. 1. Elevation of bridge geometry.

ballast to balance the moment at the main pier. The total length of the bridge was 386 m (Fig. 1). The thickness of the bottom slab varied from 1.15 m at the main piers to 0.18 m at the span. The web thickness of bridge was 0.36m in the main span. The cross section and hinge are shown in Fig. 2.

The collapse of a record 240.8m long clear-span prestressed-concrete bridge after being in service for 18 years, in the Pacific island nation of Palau, occurred without any failure indications in 1996. Korror-Babeldaob Bridge was connecting Korror, Babeldaob Islands. The failure of the KB Bridge in Fig.1, occurred on 26 September 1996, at around 5.45 afternoons (Burgoyne and Scantlebury, 2006). The collapse of record span bridge (Yee, 1979) was catastrophic, killing two people and injuring four more, and occurred under virtually no traffic load during benign weather conditions. Services passing through the bridge between the country's two most populated islands were severed; this caused the government to declare a state of national emergency and request international aid for the thousands of people left without fresh water or electricity.

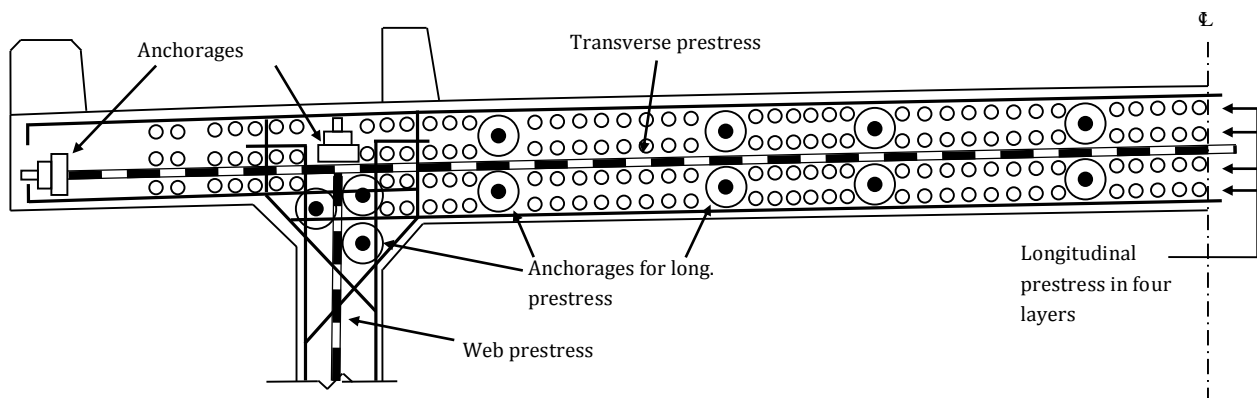
Fig. 3. Detail of top flange reinforcement.

According to design, the initial total longitudinal prestressing force above the main pier was 182.4 MN ($\approx 0.70 \times 316 \times 812 \times 1050$ N), and was provided by 316 parallel high-strength threaded bars of diameter 32 mm and strength 1050 MPa (Fig. 3). Effective prestress was assumed as $f_{ef} = 0.7f_y$. The mass density of concrete was $\rho = 23.25$ kN/m³. Top slab covered by concrete pavement of average thickness 75mm. The aggregate was crushed basalt rock of maximum aggregate size about 19 mm, supplied from a quarry on the island of Malakal. The bars

(the ducts of diameter 47.6 mm, later injected by grout) were placed in up to four layers within the top slab. Extended by couplers and anchored near the abutment, the prestressing bars had the diameter 32 mm and run continuously up to the segment of the main span at which the threaded ends were anchored by nuts. Threaded bars lengths in longitudinal direction were changing from 1.6 m to 18.3 m (7 different length).

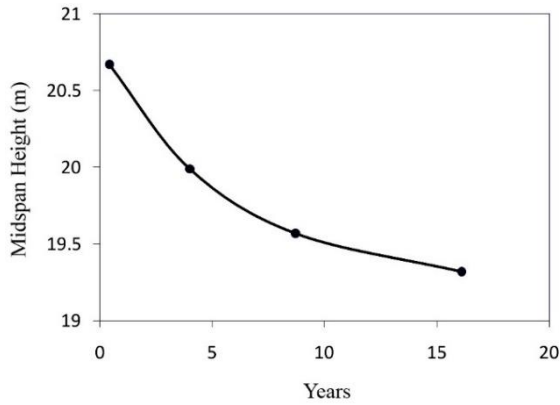
Fig. 4. Measured long-term deflection at midspan.

The bridge was completed in April 1977, after which it remained unchanged for the next 18 years. On the period the cantilevers deflected due to creep, shrinkage and prestress loss. By 1990 the sag of the centre line, is shown in Fig. 4, had reached 1.2 m (Klein, 2007) affecting the appearance of the bridge causing discomfort to road users, and damage to the wearing surface.

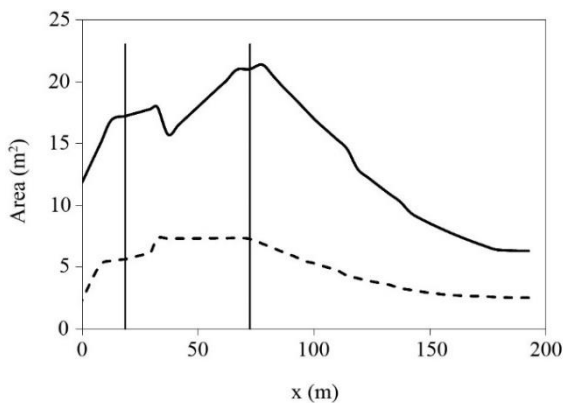
Fig. 5. Cross-sections along the bridge.

The detailed geometry of one half of the structure is shown in Fig. 5. The x -coordinate used here is measured from the extreme back of bridge, with rear support at $x=18.6$ m, and the main support at 72.25 m. This leaves a cantilever of 120.4 m. Variation of centroid location is also shown as dashed curve.

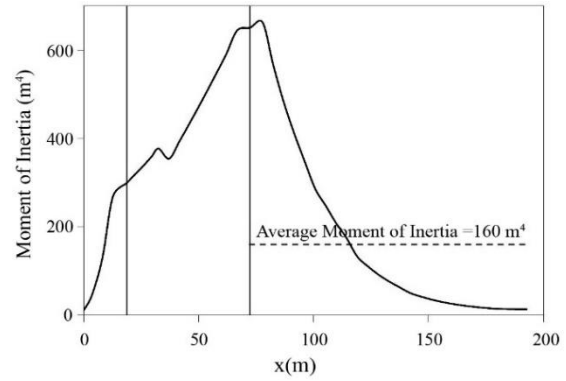
Fig. 6. Moment of inertia of the bridge.

Variation of moment of inertia of the bridge was given in Fig. 6. In this figure average moment of inertia $I=160$ m⁴ was given as dashed line.

where, δ =vertical displacement, P =concentrated truck loading, L =length of cantilever, EI =stiffness of box section bridge. By using the measured displacement $\delta=0.0305$ m under the truck loading ($P=250$ kN), in Eq. (1), $EI=250 \times 120.4^3 / (3 \times 0.0305) = 4.76 \times 10^3$ Nm² will be obtained. By the help of stiffness and I value from the Fig. 6, elasticity modulus of concrete was found as, $E=4.76 \times 10^3 / 160 = 29.8$ GPa.

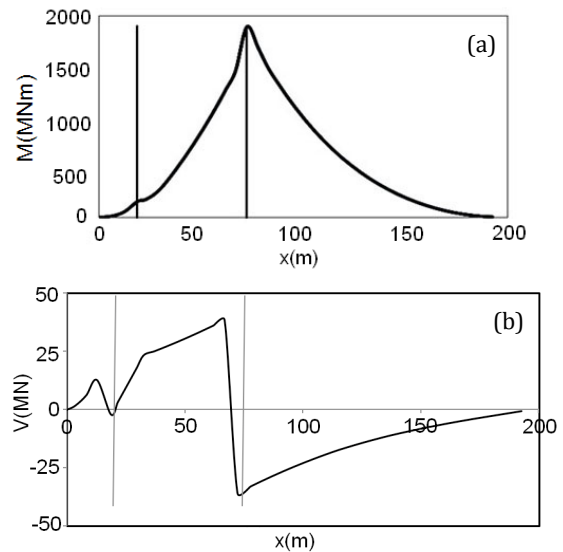
Fig. 7. Under the dead weight including ballast and pavement, a) bending moment, b) shear force diagram.

Fig. 7 shows that the as-built bending moment and shear force diagram due to the bridge's self-weight for one cantilever as a solid line. The plotted values included the effect of the ballast in the back span and weight of pavement since these are permanent load. The peak moment at the main support is 1893 MNm while at $x=84.8$ m the moment is 1418 MNm (Fig. 7(a)) and the shear force 32.0 MN (Fig. 7(b)).

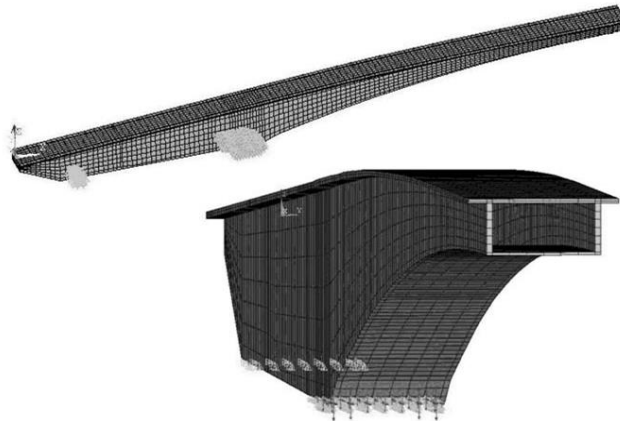
Fig. 8. Finite element mesh generation and boundary conditions of the model.

Box girders have been analyzed according to the classical engineering theory of bending in which the cross sections are assumed to remain plane. In Fig. 8, ANSYS finite element modeling is shown. In this simulation of bridge with ANSYS using 5392 hexahedral three-dimensional (3D) finite element with 9614 nodes were used. For threaded bars, 1014 line element by using node numbers in each 45 segments were used. In this section regular reinforcement ratio of the reinforced concrete was chosen as $\rho=0.003$.

As part of the assessment of the bridge a loaded truck weighting 125 kN was driven on the tip of each cantilever to determine its stiffness. Displacement at the tip of cantilever under the self-weight, pavement weight including ballast and prestress was give 127.83 mm, own weight, pavement, ballast, prestress under truck loading give 157.43 mm. Difference between these two displacements 29.6 mm is close enough to 30.5 mm, which is given in McDonald et al. (2004). In this case concrete model is close enough to real concrete used at Palau Bridge in vertical deflection.

A downward deflection of 30.5 mm was recorded at a midspan when two 125 kN trucks were parked on each side of the midspan hinge. The main goal in this study to compare the results of finite element code based on model Hognestat which give the same deflection as 29.6 mm under the load of 250 kN. The displacement at the midspan of bridge was found close enough to the ANSYS finite element results.

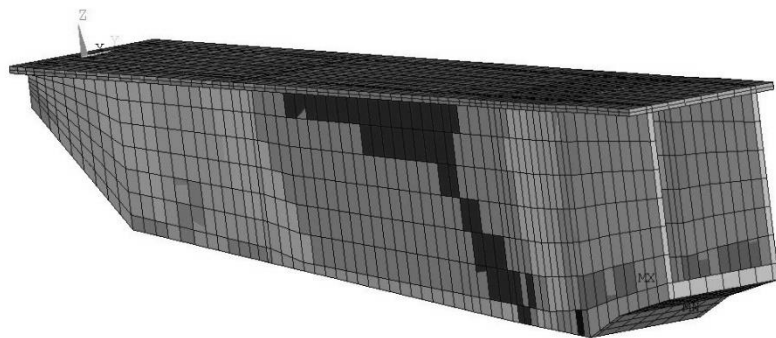
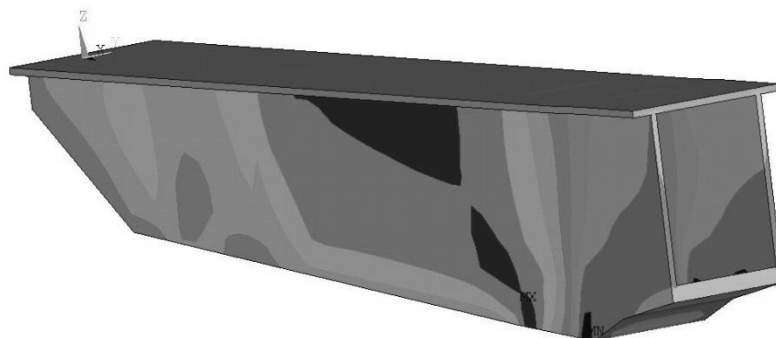
Fig. 9. Shear stress distribution at $x=7.08$ m under self-weight and prestress, a) element solution, b) nodal solution.

KB bridge was collapsed under shear force at $x=7.08$ m far from the main pier face. For this reason stress distribution at $x=7.08$ m was important for this analysis. In Fig. 9 the distribution of shear stress in a cross section

located at 7.08 m away from main pier face, is shown when only self-weight or only prestress is considered. It

can be seen that a significant shear stress exists in the top and bottom slabs near main pier.

The total deflection is sensitive because it represents a small difference of two large numbers corresponding to self-weight and to prestress. The shear force plays a more important role in downward deflection by self-weight than upward deflection by prestress. Therefore the neglect of shear may lead to a considerable underestimation of the long-term deflection.

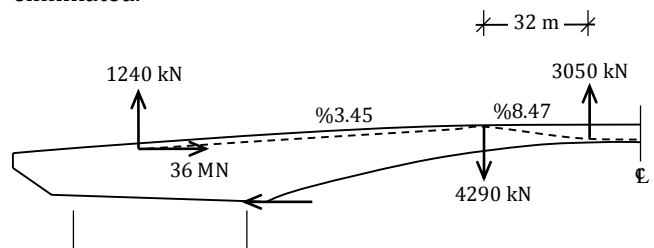
Fig. 10. Forces induced by continuity cables.

displacement at the cantilever end under the M , $\delta=108 \times 10^6 \times 120.4^2 / (2 \times 4.76 \times 10^{12}) = 0.16$ m was obtained. The vertical and horizontal component of forces exerted by the cable, which is shown with dashed line on the bridge, is given in Fig. 10. Required M for the total displacement $\delta=1.61$ m, was found by using Eq. (1) as $M=1.61 \times 2 \times 29.8 \times 10^3 \times 160 / 120.4^2 = 1059$ MNm. To prevent the prestress loss in bars which already build in the cross section, 20% is enough for displacement, and taking the lever arm 2 m, cantilever end moment $M=0.2 \times 182.4 \times 2 = 73$ MNm was obtained. By this way, $\delta=73 \times 1.61 / 1059 = 0.11$ m vertical displacement, will be eliminated.

During the repairing process, for lifting of bridge at center, help of additional prestressing bars applied 36 MN force. Assume the lever arm of prestressing bars as a 3 m, taking $M=36 \times 3 = 108$ MNm, and using Eq. (2),
