Research Article

Experimental examination of strength and behavior of masonry brick walls strengthened with expanded steel plates

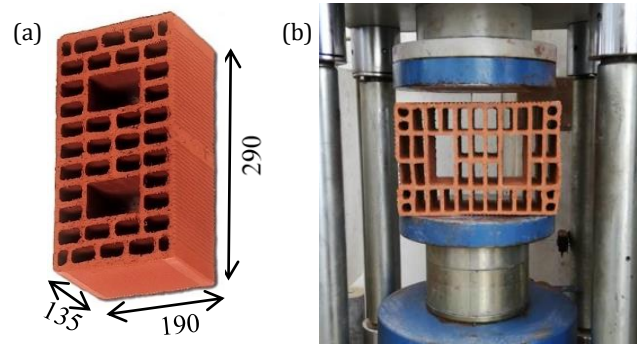
Fig. 1. (a) Vertical-hole brick; (b) Compressive strength tests.

The specific weight (γ) of the bricks used in the study was 700 kg/m³. To determine the characteristics of the bricks, 30 bricks were separately tested to find the brick properties (Fig. 1). The compressive strength of the bricks was examined according to the TS EN 772-1+A1 standard (Table 2).

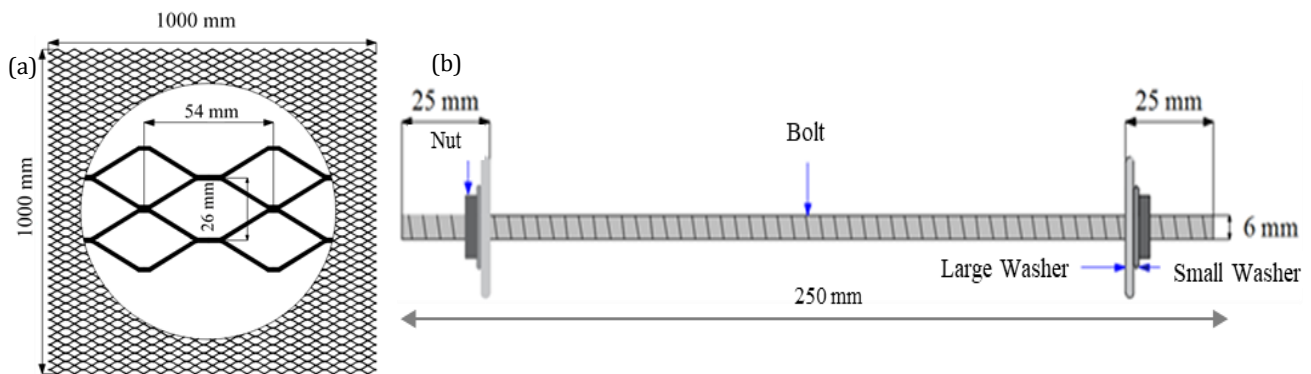
Fig. 2. Materials used in wall strengthening: (a) Expanded steel plate; (b) Geometries of the bolt, washer, and nut.

The thicknesses of the expanded steel plates were 1.5, 2.0, and 3.0 mm with an average yield strength (σ_y) of 280 MPa. The steel plates were processed in a factory using cutting and expanding procedures, and expanded steel plates with perforations having dimensions of 54×26 mm were obtained. No welding or mounting procedures were applied on expanded steel plates (Fig. 2(a)).

To attach expanded steel plates to the walls, bolts, washers, and nuts were used (Fig. 2(b)). The bolts were produced by cutting 250 mm-long pieces from 6-mm fully threaded 1-m long S235 steel bars.

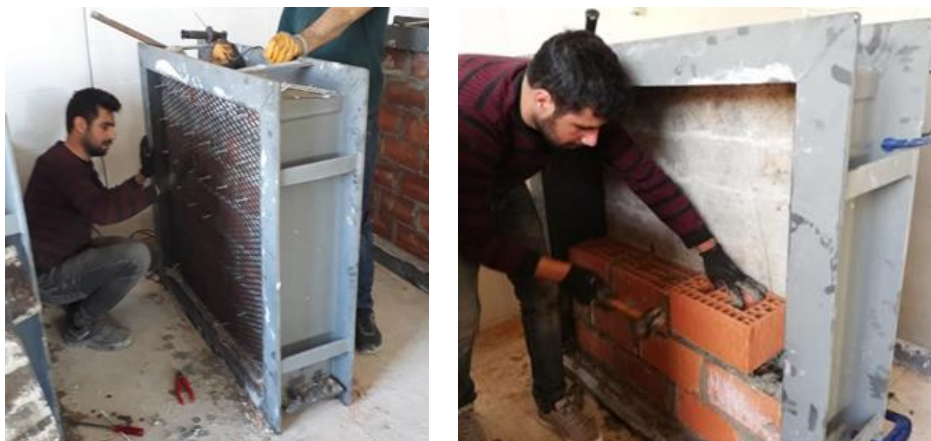
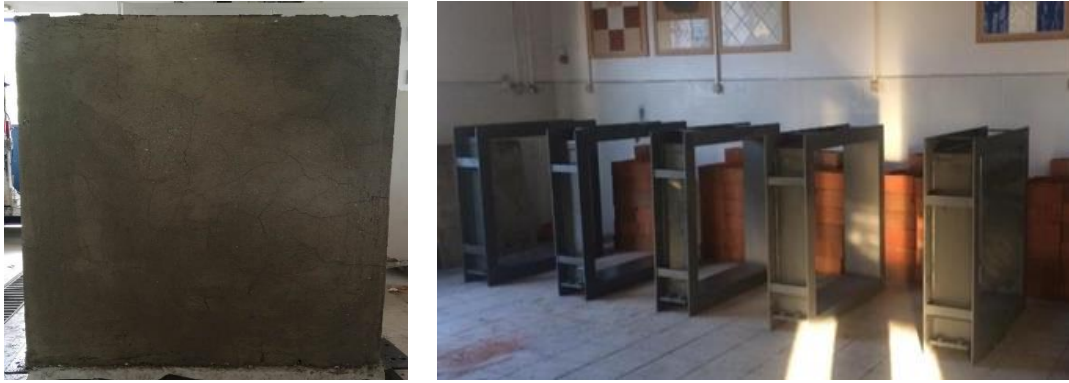
Fig. 3. Preparation of the experimental setup.

Holes were drilled at the determined points on the wall specimens with a drill, expanded steel plates were then placed on the walls, and fixed using bolts, washers, and nuts (Figs. 3 and 4).

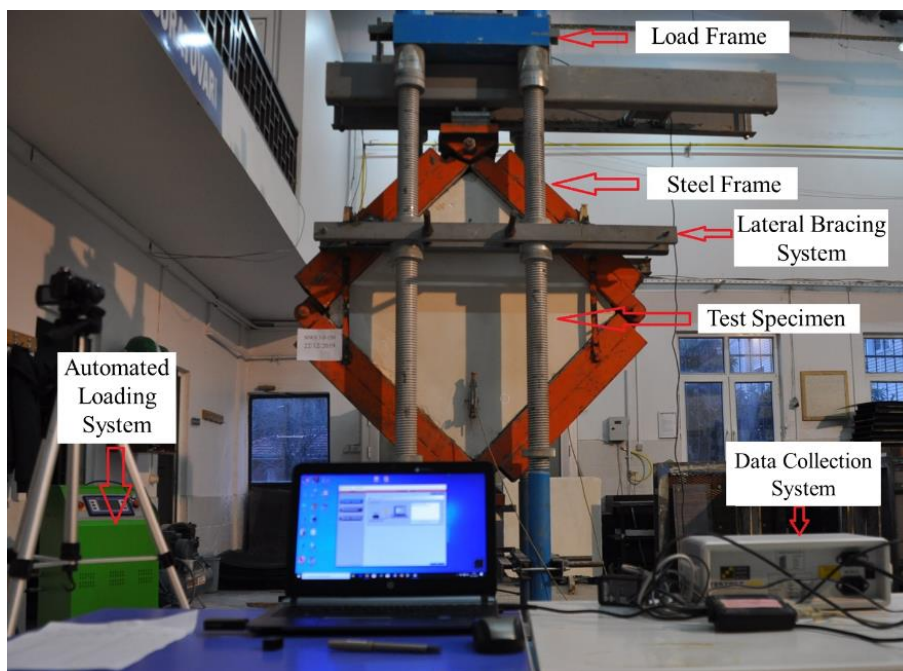
Fig. 6. Test setup.

(Fig. 6) through a speed-controlled loading system depending on the displacement. The loading speeds varied according to the displacements as follows: 5% up to 10 mm displacement, 25% up to 10-35 mm displacement, and 50% beyond 35 mm displacement.

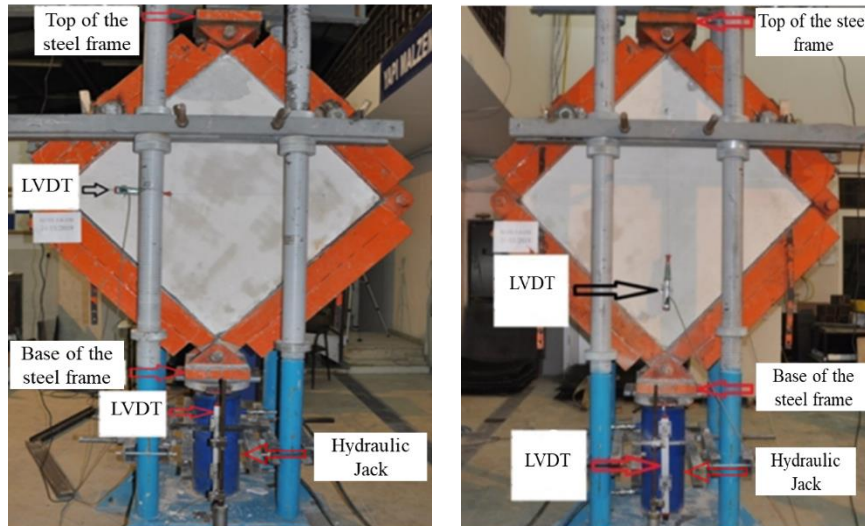
Fig. 7. Placement of LVDTs.

To measure the displacements in the test specimens, 4 LVDT (Linear Variable Differential Transformer) were used. Two 400 mm LVDT were attached to the base of the rigid frame to measure shortenings of the specimens

along the loading axis. Two 50 mm LVDT were placed on the front and back of the test specimens to measure shortenings of the specimens along the loading axis and elongation perpendicular to the loading axis (Fig. 7).

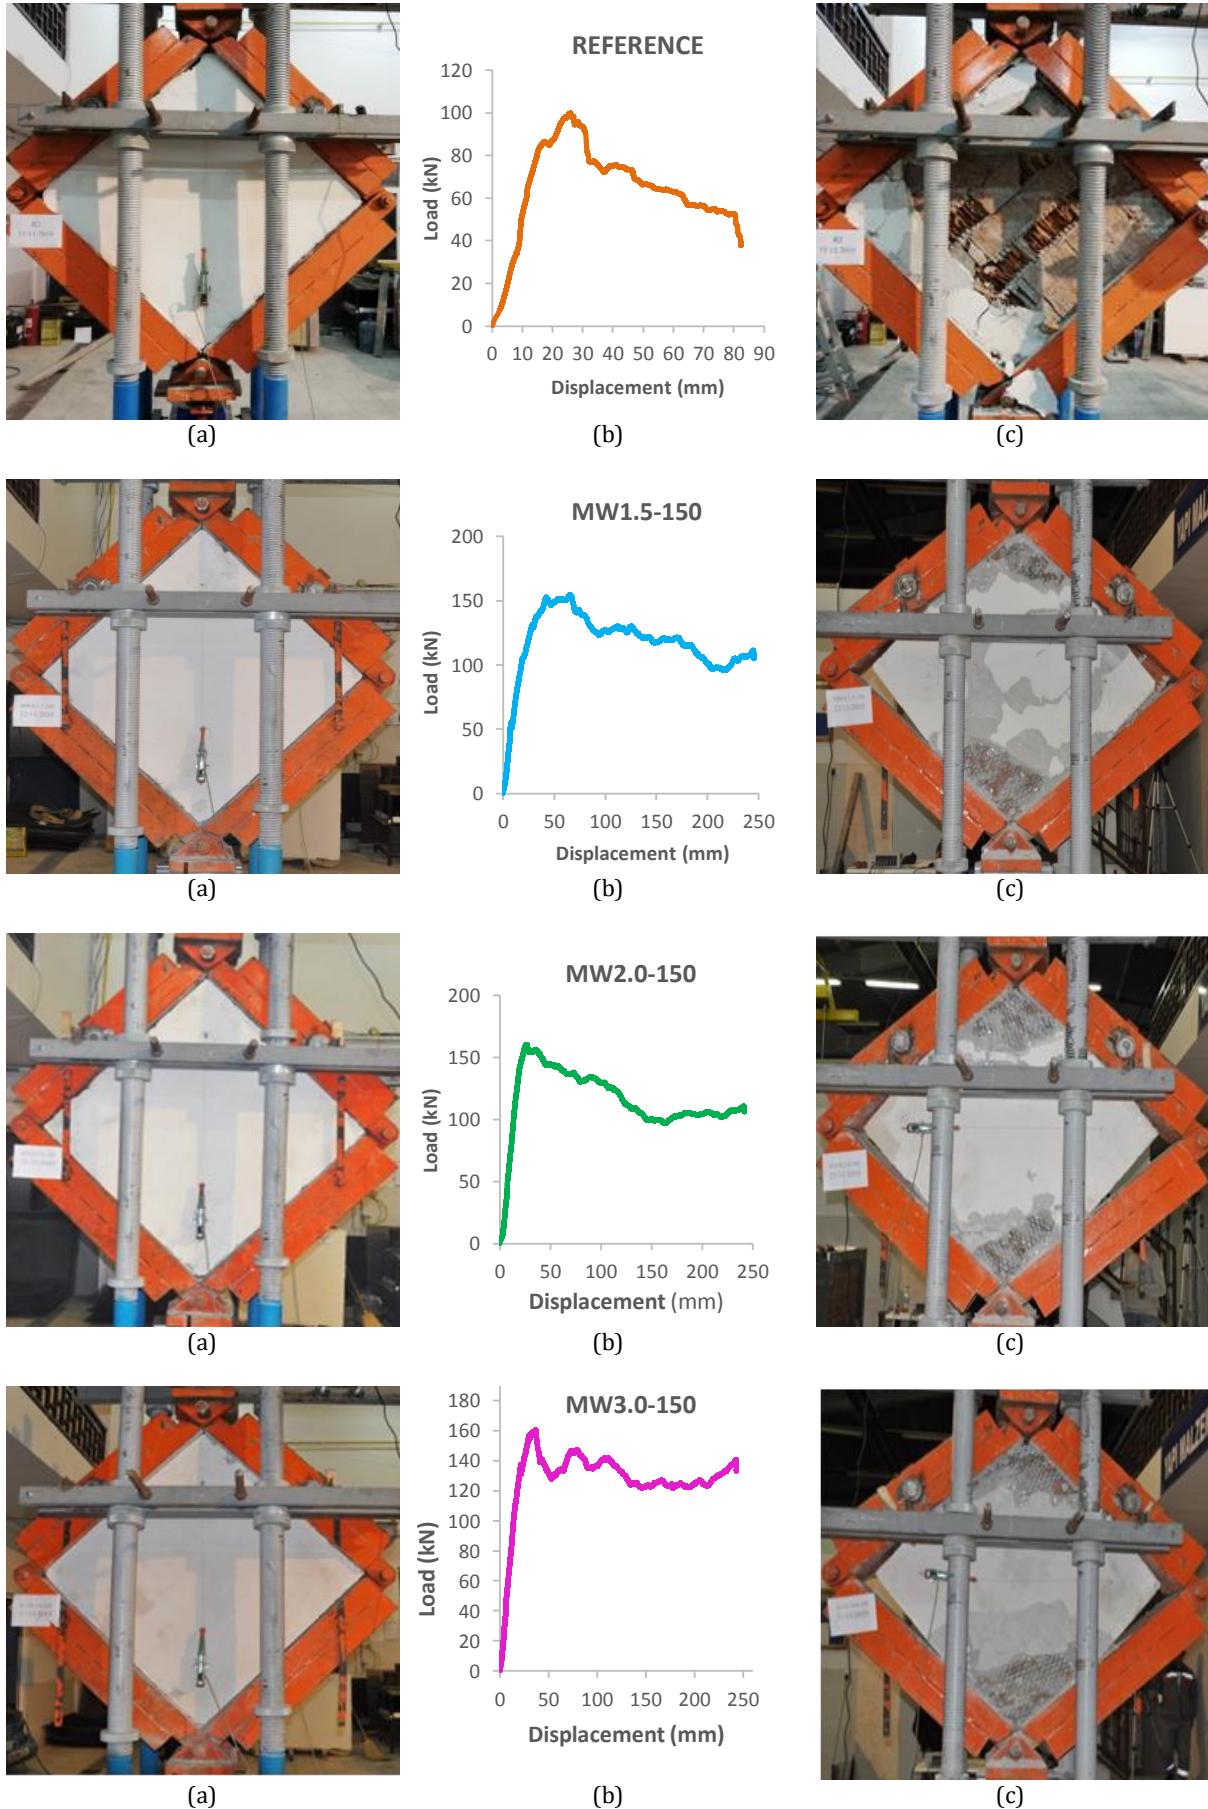
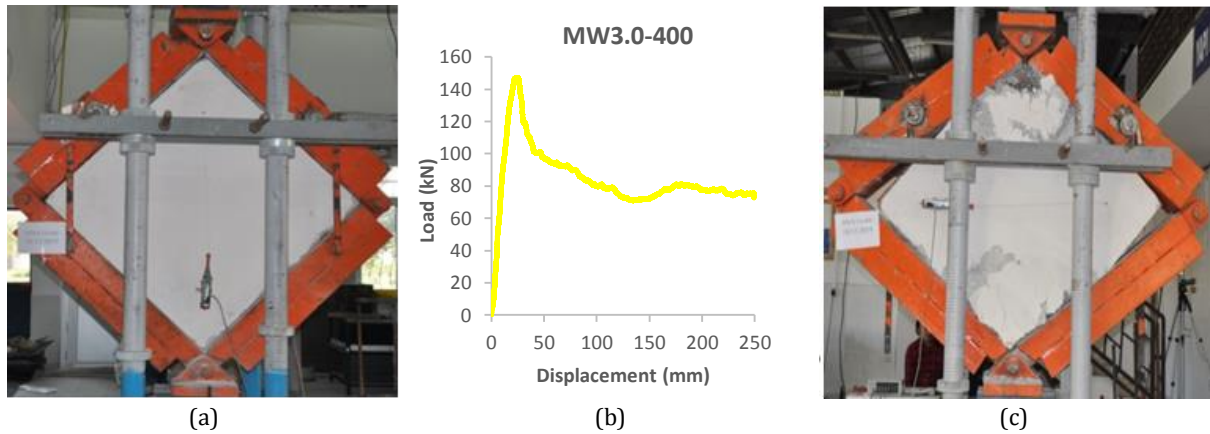
Fig. 8. Test members: (a) Before the test; (b) Load-displacement curve; (c) After the test.

Only plastering layer was applied to both sides of the reference specimen and no strengthening material was used. During the tests, the reference specimen exhibited very brittle behavior and had abrupt load drops. Since abrupt load drops occurred and the reference specimen showed non-ductile behavior, a very limited amount of displacement was observed. After the test started, fine hairline cracks were observed on the both front and back plaster surfaces at a load of 60 kN and a displacement of 31 mm. The first crack was observed 20 cm from the right side of the middle diagonal of the specimen at a load of 85 kN and a displacement of 36 mm. The width of the first crack was measured to be approximately 3 mm. Towards the end of the experiment, the cracks continued to grow and blisters became more evident. The maximum load-carrying capacity of the reference specimen was measured 99.87 kN and the displacement was recorded 25.9 mm. The test was terminated after a displacement of 90 mm since the specimen no longer carry any loads. The contact surface of the reference specimen was measured as about 70% (70 cm).

For the specimen MBW 1.5-150, obvious blisters progressing towards the frame was observed on both front and back surfaces of the specimen around the hinges at a load of 125 kN and a displacement of 91 mm. The maximum load-carrying capacity of the specimen was noted 154.65 kN and the displacement at this load was counted 65.5 mm. The contact surface of the specimen was measured as 65% (65 cm) on average.

For the specimen MBW 2.0-150, obvious lateral blistering was observed on both front and back surfaces of the specimen around the lower hinge due to compression at a load of 141 kN and a displacement of 64 mm. Plus, some blistering progressing towards the frame

around the hop hinge was also observed. The maximum load-carrying capacity of the specimen was found to be 160.2 kN and the displacement at this load was calculated as 34 mm. The contact surface of the specimen MBW 2.0-150 was measured as 58% (58 cm) on average.

For the specimen MBW 3.0-150, hairline cracks were observed on the middle region of the plaster both on front and back surfaces of the specimen at a load of 147 kN and a displacement of 28 mm. Furthermore, a significant plaster crack in the loading direction was observed on the back surface of the specimen near the lower hinge and blistering around the top hinge due to compression. On the other hand, at a load of 135 kN and a displacement of 122 mm, lateral cracks and about 30 cm above the lower hinge blistering on both front and back surfaces and plaster blisters progressing towards the frame were observed due to compression. The maximum load-carrying capacity of the specimen MBW 3.0-150 was found to be 160.35 kN and the displacement at this load was calculated as 36.76 mm. The contact surfaces of the specimen MBW 3.0-150 on four corners were measured as 48% (48 cm) on average.

Finally, for the specimen MBW 3.0-400, hairline plaster cracks in the middle region of the front surface were observed at a load of 145 kN and a displacement of 28 mm. Plus, plaster blistering and falling off occurred on the front surface of the specimen near the top and lower hinges due to compression. The maximum load-carrying capacity of the specimen was calculated as 147.28 kN and the displacement at this load was found to be 23.59 mm. The contact surface of the specimen MBW 3.0-400 was measured as 60% (60 cm) on average.

The undamaged state of the specimens, the damage condition after the test and the load-displacement curves are shown in Fig. 8. Test results were summarized in Table 4.

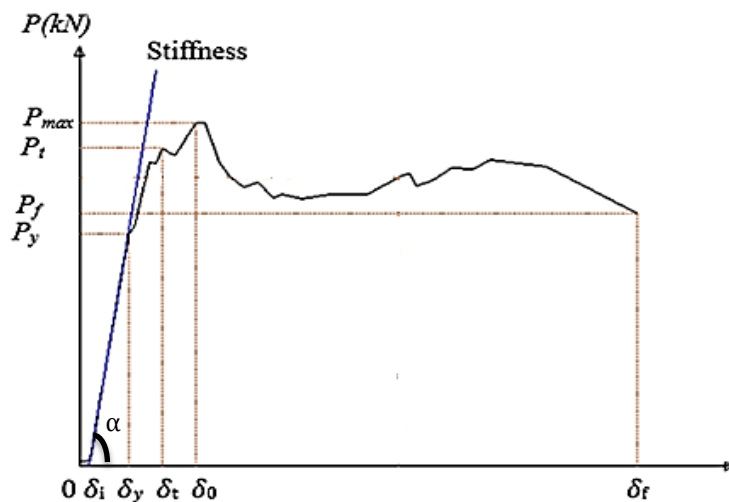
Fig. 9. A sample load-displacement curve used to calculate the ductility of the specimens.

The carrying capacity, stiffness, and ductility capacities of the specimens were calculated according to Fig. 9 using the test results. In the curve, (P_y) is load-carrying capacity at yield, (δ_y) is displacement at yield, (P_{max}) is maximum load-carrying capacity, (δ_0) is displacement at

maximum load, (δ_f) is maximum displacement, (P_f) is load-carrying capacity at maximum displacement, (δ_i) is displacement at the beginning of the stiffness curve, (P_t) is load-carrying capacity, and (δ_t) is the displacement corresponding to P_t .

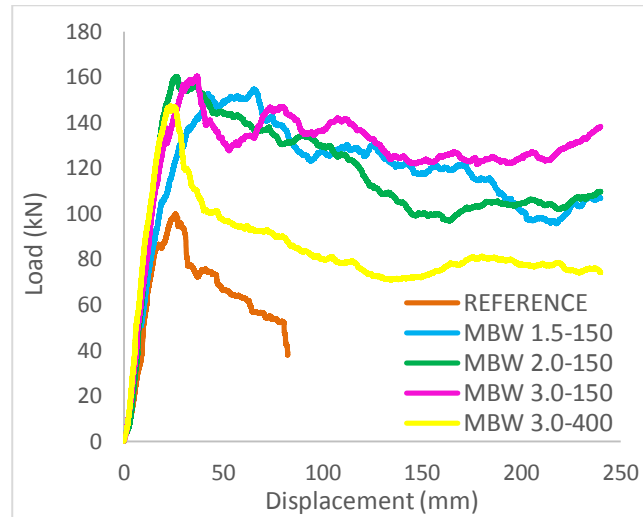
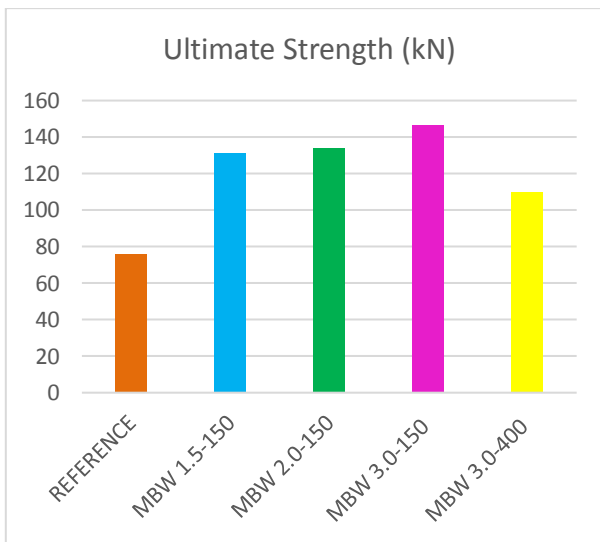
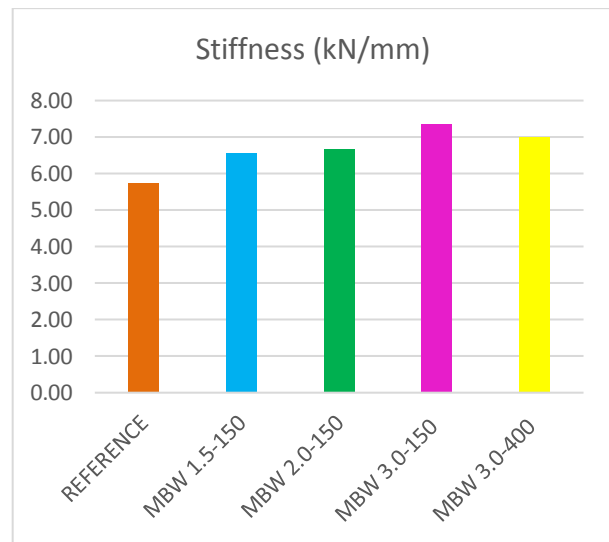
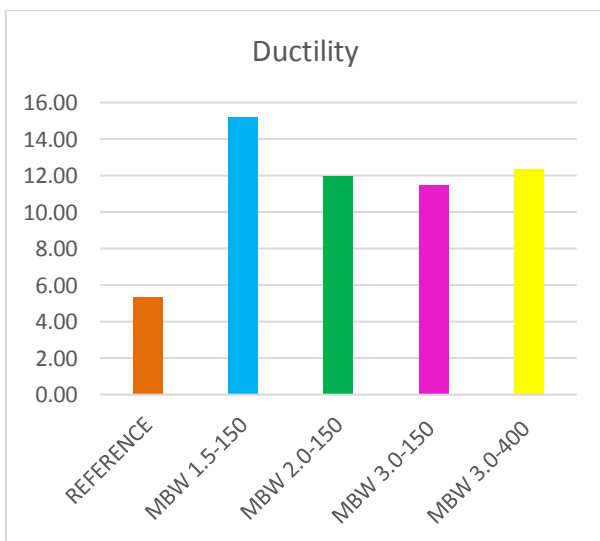
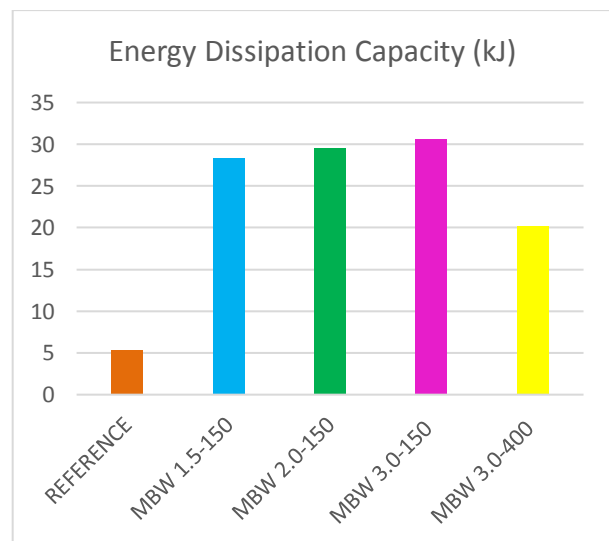
Fig. 10. Comparative presentation of the specimens' load-carrying capacities, stiffness, ductility, and energy dissipation capacities.

The load-displacement curves of all specimens are shown in Fig. 10(a). Load-carrying capacities, stiffness, ductility, and energy dissipation capacities of the specimens are comparatively given in Figs. 10(b-c-d-e).
