Research Article

Effect of elevated temperatures on mechanical properties of hydraulic lime-based mortar in historical structures

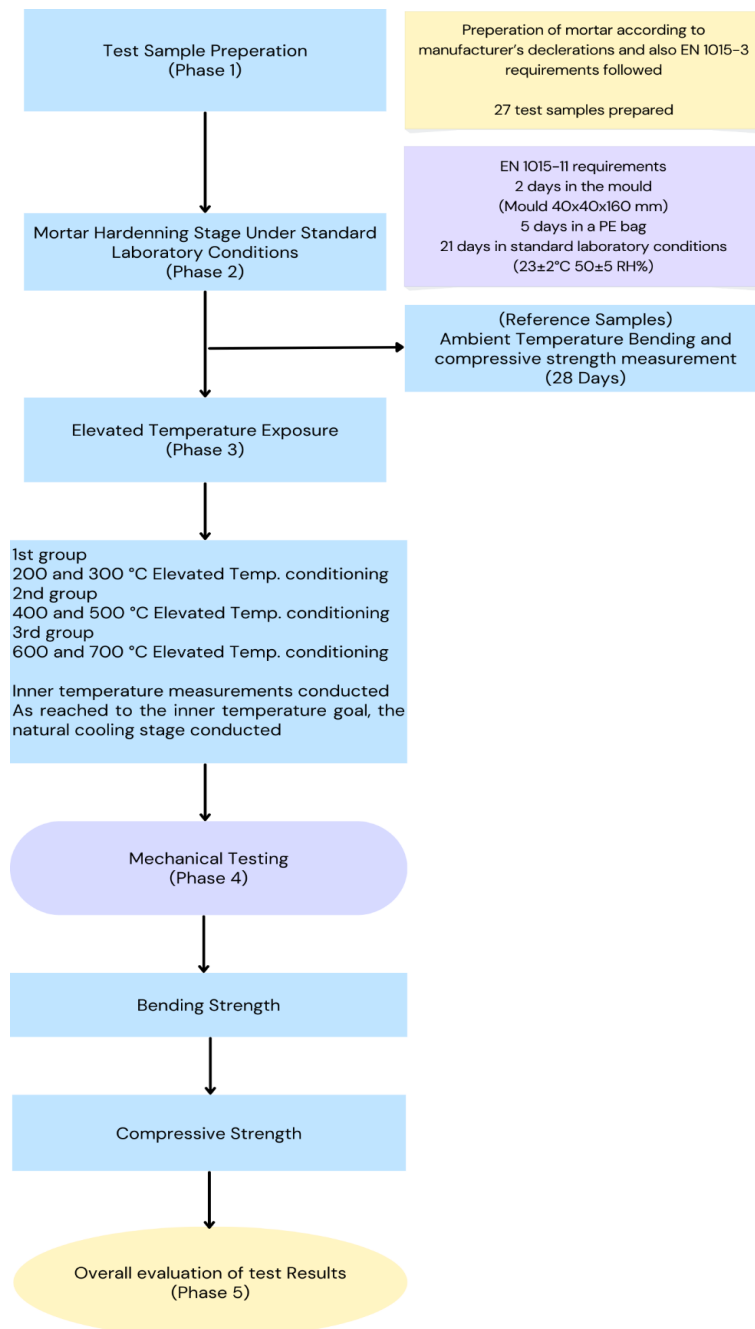
Fig. 1. Flowchart for the study.

were then subjected to bending and compression tests at temperatures ranging from 200 °C to 700 °C after being exposure to high temperatures. A total of 27 samples were included in the high-temperature tests, with three experimental samples, one temperature-monitoring sample, and three reference samples for each temperature. The reference samples were tested at room temperature, whereas the other samples were held at room temperature after completing the fire test and then tested under the same conditions as the reference samples. No tests were conducted on the temperature-monitoring samples; they were only used to monitor the internal temperatures of the samples using the embedded thermocouples that differs from past studies. In this study, all steps were performed according to the flowchart (Fig. 1).

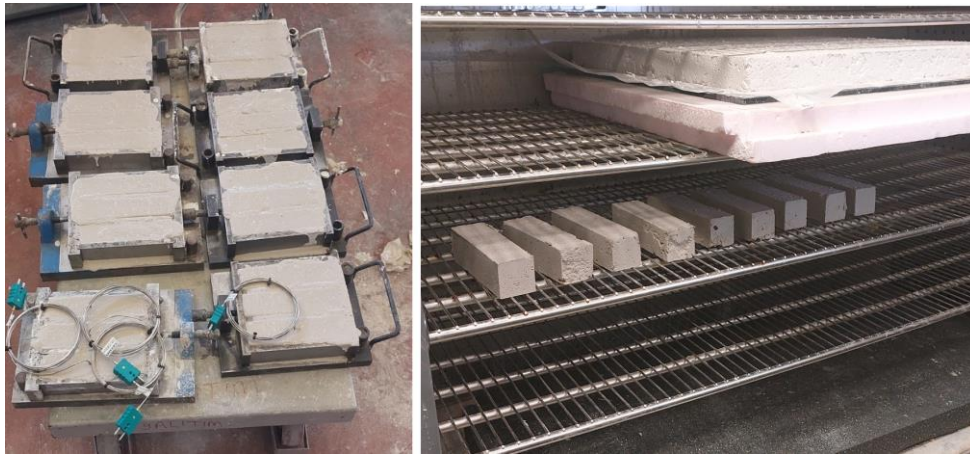
Fig. 2. Test specimens.

To prepare the specimens, Teknorep520 was mixed at 20/6 water content ratio in the laboratory. Subsequently, the mixed mortar was poured into molds measuring 40 × 40 × 160 mm, according to the specifications outlined in EN 1015-11. These specimens were then en-

closed in polyethylene bags to maintain a relative humidity of 95% ± 5, as to the guidelines provided in EN 1015-11 (Fig. 2). After a period of five days, the specimens were extracted from the molds and kept in polyethylene bags for an additional two days, for a 7-day duration. Subsequently this, the specimens were transferred to laboratory conditions of 65% ± 5% relative humidity and 20 °C for further testing.

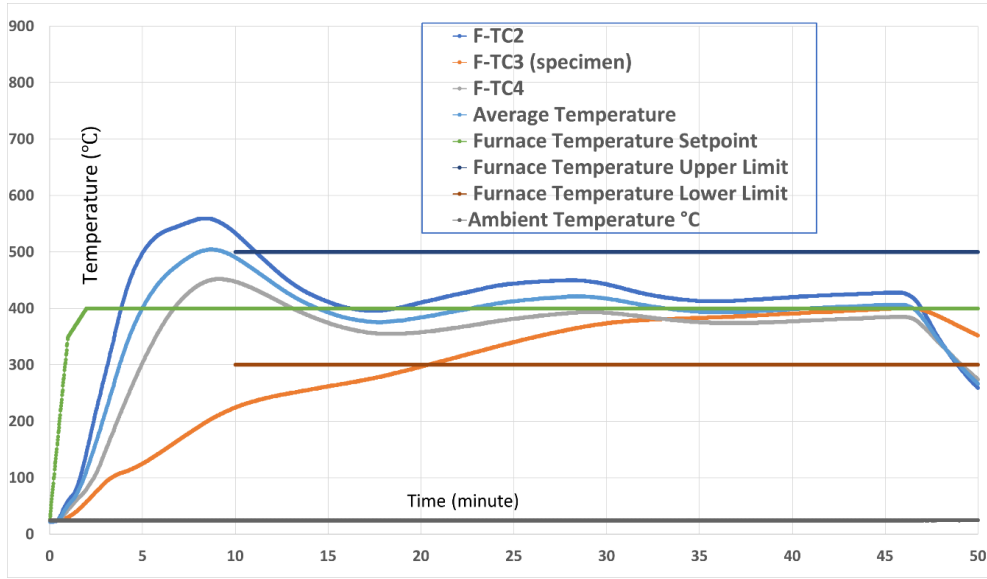
Fig. 7. Time-temperature exposure curve for 400 °C test specimen.

the furnace cover was removed, and both the furnace and specimen were allowed to cool until below 100 °C, with the cooling phases meticulously recorded. The standard temperature-time curve obtained from the thermocouples is shown in Fig. 4, and the temperature profiles for elevated conditions are depicted in Figs. 5–10.

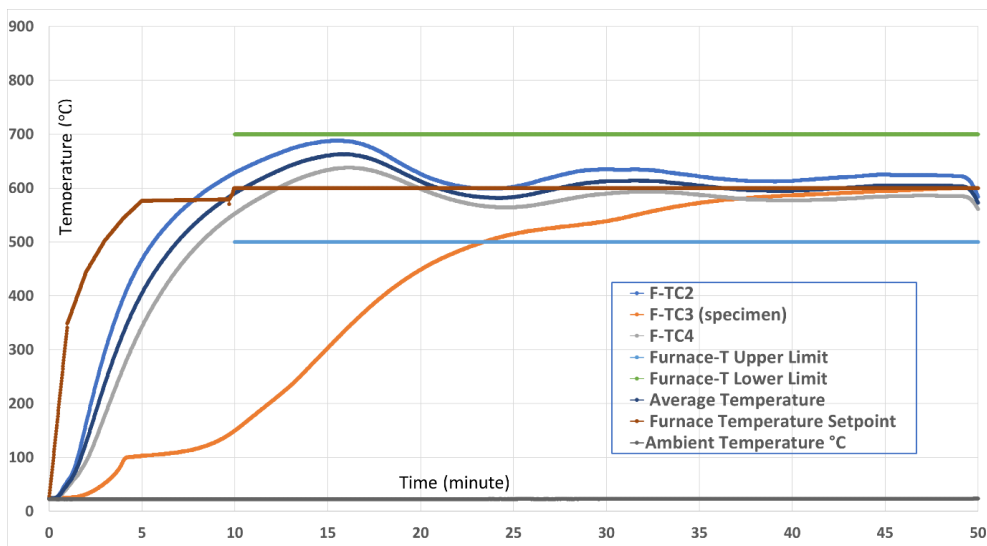
Fig. 9. Time-temperature exposure curve for 600 °C test specimen.

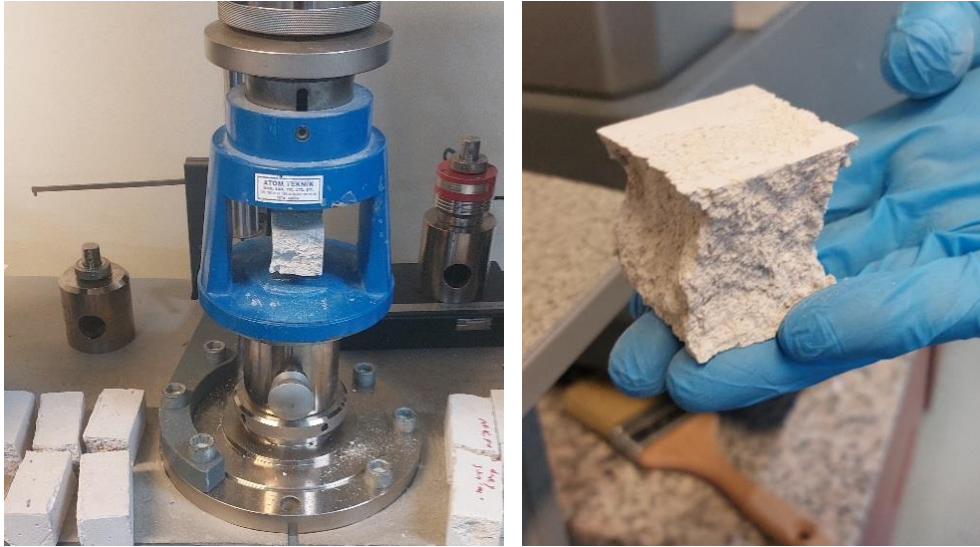
Fig. 12. Compression test on the specimens.

In addition to the bending tests, compression tests were conducted on separate specimens exposed to each temperature level during ETTs (Fig. 12). The specimen mechanical tests were performed 1-day after ETTs in order to be sure cooled to room temperature. Compression tests involve the application of axial loads to specimens to determine their compressive strength and deformation behavior. These tests help to understand how the material responds to compressive forces, which is vital for evaluating its structural stability and load-bearing capacity.

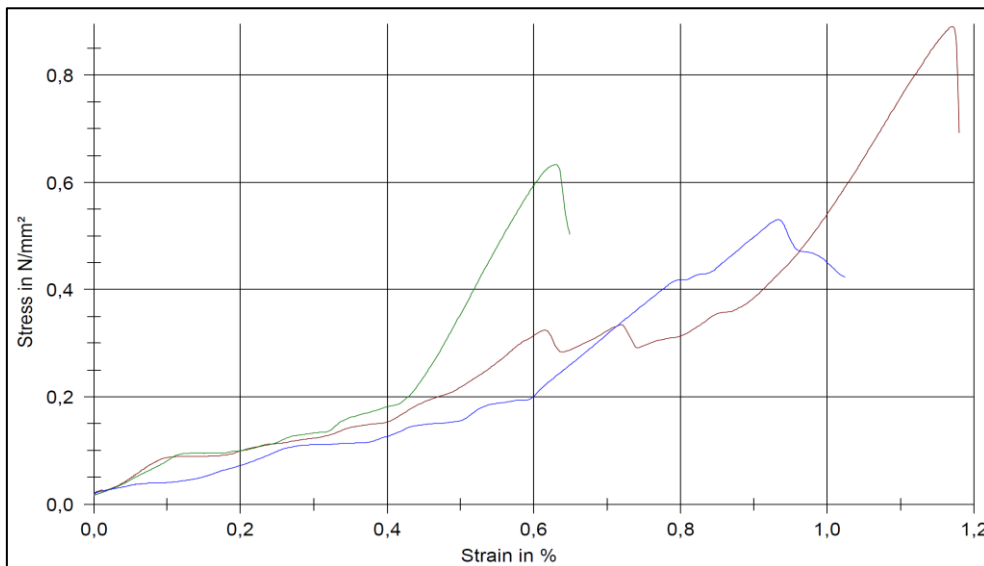
Fig. 17. The flexural strength at 500 °C.

The flexural strength exhibited a distinct pattern with an increase in temperature. At 200 °C, the flexural strength decreased to approximately 70% of the ambient level, followed by a gradual decline of approximately 10% per 100 °C until reaching 700 °C. Ultimately, the flexural strength to a mere 20% of the ambient level at the highest temperature point. This gradual decrease underscores the susceptibility of the material to thermal degradation over prolonged exposure to elevated temperatures (Figs. 13–19).

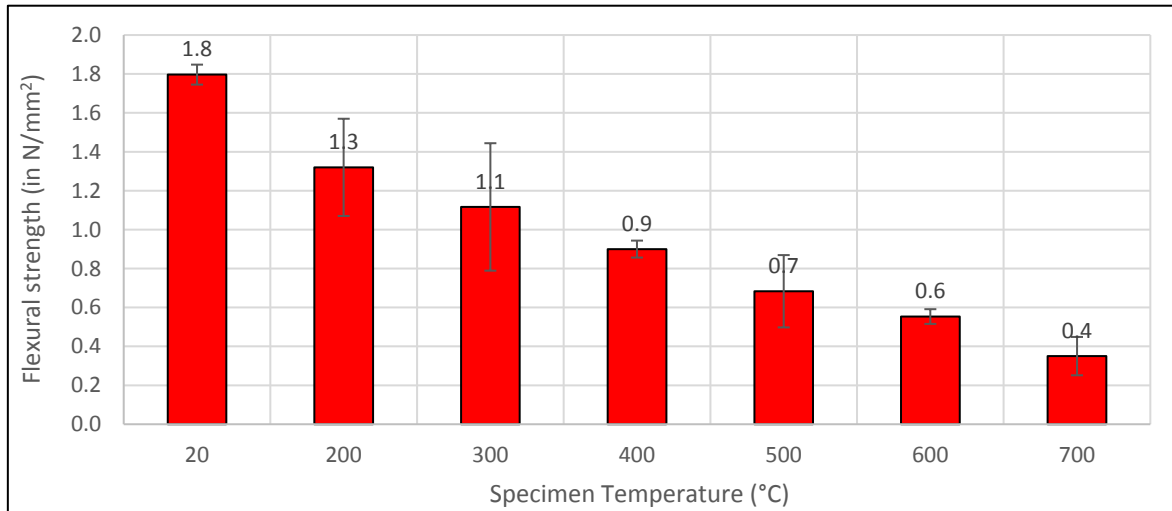
**Fig. 20.** Summary of flexural strength test results.**Table 3.** Energy absorption of the specimens (Joule).

Table 2 presents the results of the flexural tests conducted on HLM specimens subjected to varying temperatures. As observed from the data, there was a clear trend in the flexural strength of the mortar as the temperature increased. At lower temperatures (20 °C), the control specimens exhibited the highest flexural strength, gradually decreased with increasing temperature rises. This decline became more pronounced at higher temperatures, with a significant reduction observed at 400 °C and above. The average flexural strength across all the specimens followed a similar pattern, indicating a consistent response of the mortar to thermal exposure. These findings suggest that the HLMs experienced a decline in flexural strength as they underwent thermal stress, which has implications for their suitability for applications subjected to elevated temperatures (Table 2 and Fig. 20). In a similar manner, Pachta et al. (2018) concluded that the flexural strength of the lime-based mortars gradually decreases up to 800 °C, and at 1000 °C, it is minimized. Pachta and Stefanidou
