Challenge Journal

Research Article

Performance investigation of a mixed slab building with beam and ribbed slabs

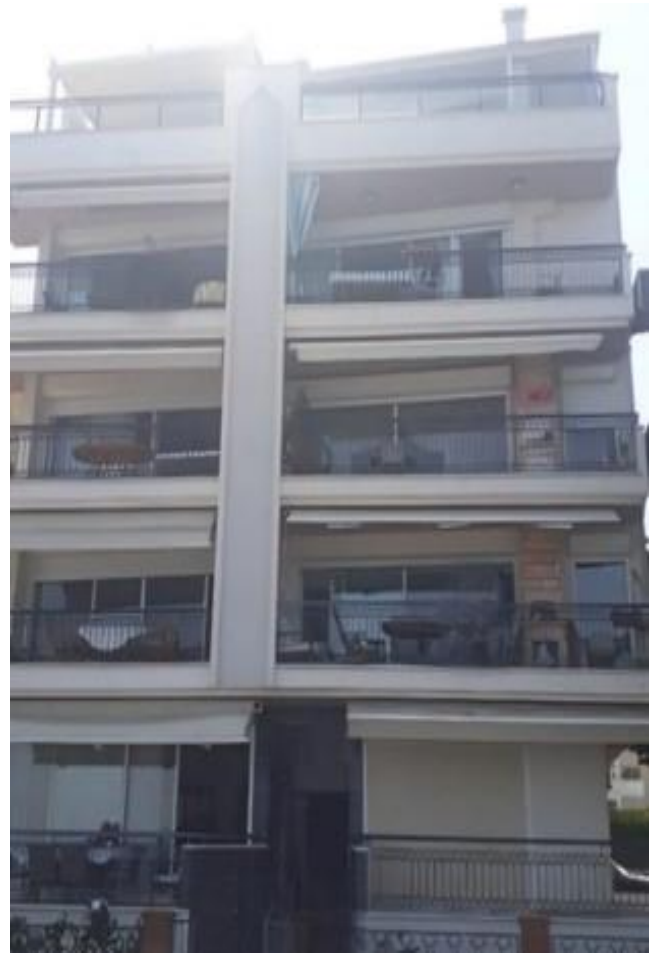
Fig. 1. Front elevation of the residential building.

As part of this study, the existing building whose seismic performance was investigated is a six-story residential reinforced concrete structure constructed in 1995. The building has a total floor area of 274.17 m² and includes one partial basement floor, one ground floor, three typical floors, and one roof floor. The story heights are 250 cm in the basement, 302 cm on the ground floor, 270 cm on the first and second floors, 302 cm on the third floor, and 260 cm in the roof floor. Based on the geotechnical investigation conducted for the building, the local soil class was identified as ZC, corresponding to very dense sand, gravel, and stiff clay layers. Examination of the slab system revealed the use of a mixed slab system. Ribbed (hollow block) slabs were used on the ground and third floors, while beam-and-slab systems were employed on the other floors. The front elevation of the building is shown in Fig. 1.

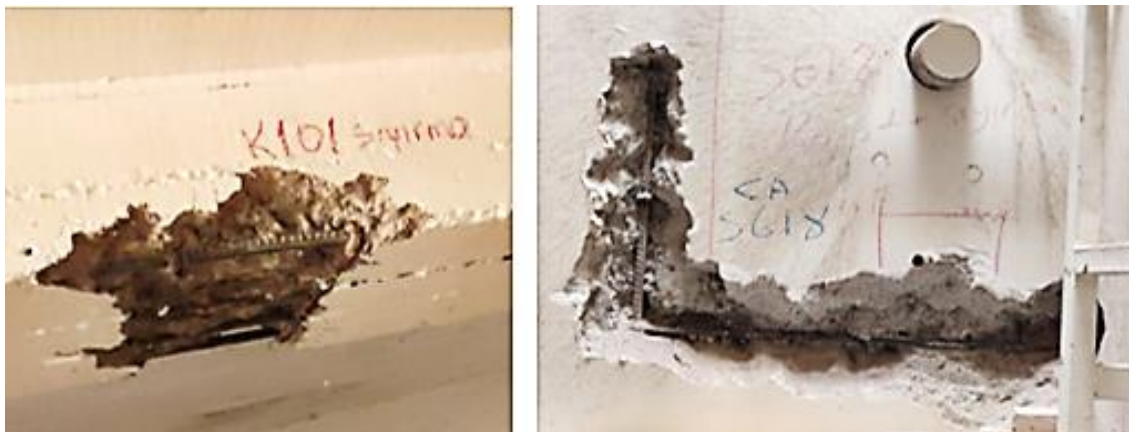
Fig. 2. Exposure of rebars.

Following the determination of the compressive strength of concrete, a reinforcement detection study was conducted to identify the existing reinforcement. As an example, the rebar exposure process performed on one beam and one column is presented in Fig 2.

To determine the cross-sectional loss in the reinforcement of reinforced concrete columns, rebar exposure tests were conducted. As an example, the structural elements on the ground floor where reinforcement investigation was performed are marked in Fig. 4. Based on the investigation, the column reinforcements were identified as S420 ribbed reinforcement steel. Additionally, no signs of corrosion were observed in the column reinforcements.

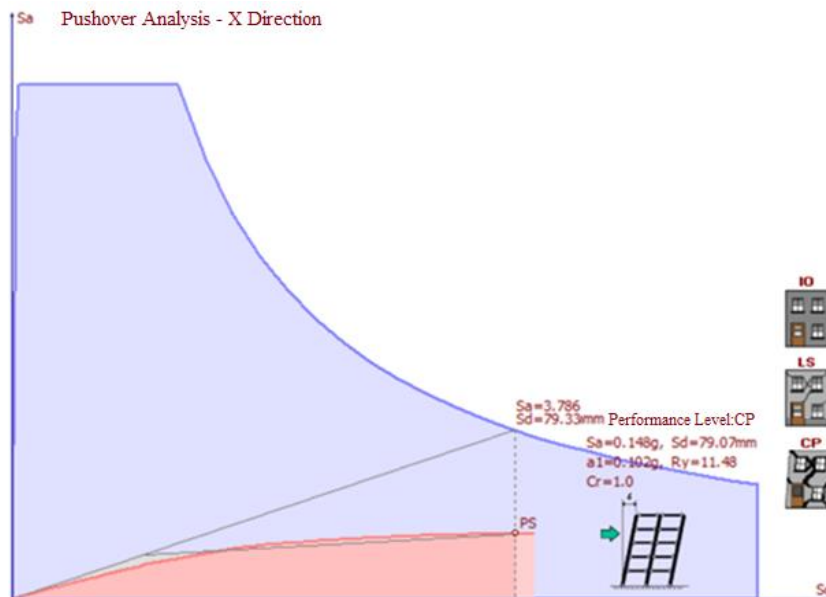
Nonlinear pushover analyses were performed in both directions of the existing building for the relevant seismic level. Target displacement values were determined as 7.9 cm and 6.6 cm for the x and y directions, respectively. The damage states of the structural system elements were evaluated as the building was pushed up to the defined performance points. The base shear force–roof displacement curves for the building are presented in Figs. 11 and 12.

Fig. 11. Pushover curve in x direction.

Fig. 12. Pushover curve in y direction.

The mass participation ratios were calculated as 66.9% and 69.4% in the x and y directions, respectively. These values fall below the 70% threshold. Additionally, the torsional irregularity coefficient was found to be 1.45, exceeding the limit of 1.40. Since the conditions for applying the single-mode pushover method were not met according to TBEC (2018), a multi-mode pushover analysis was conducted on the building. In this method, the structure is incrementally pushed using a generalized load vector until a specific story reaches its target inter-story drift ratio.

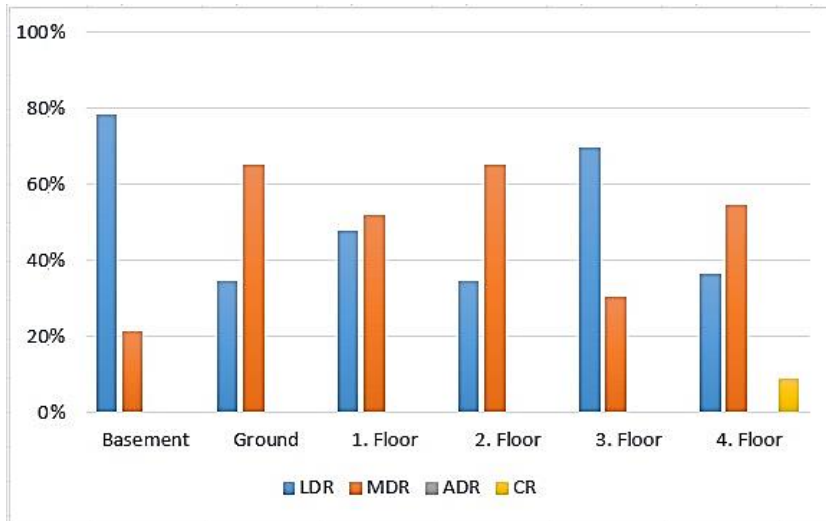
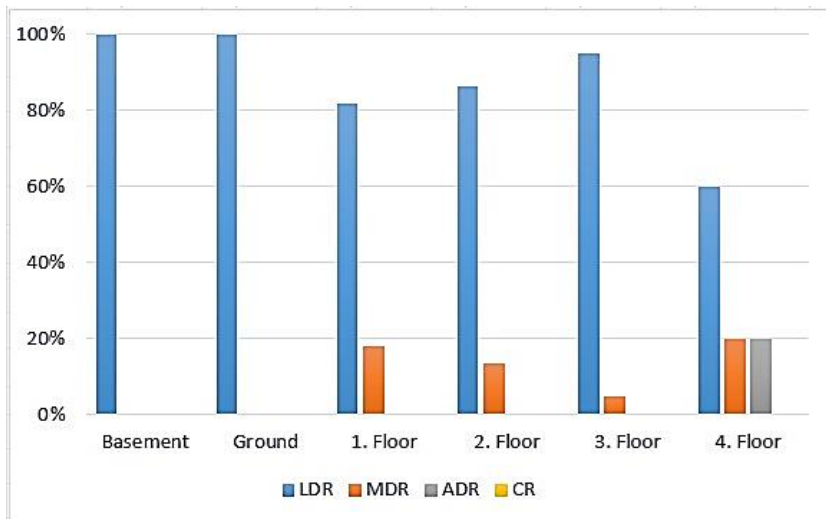
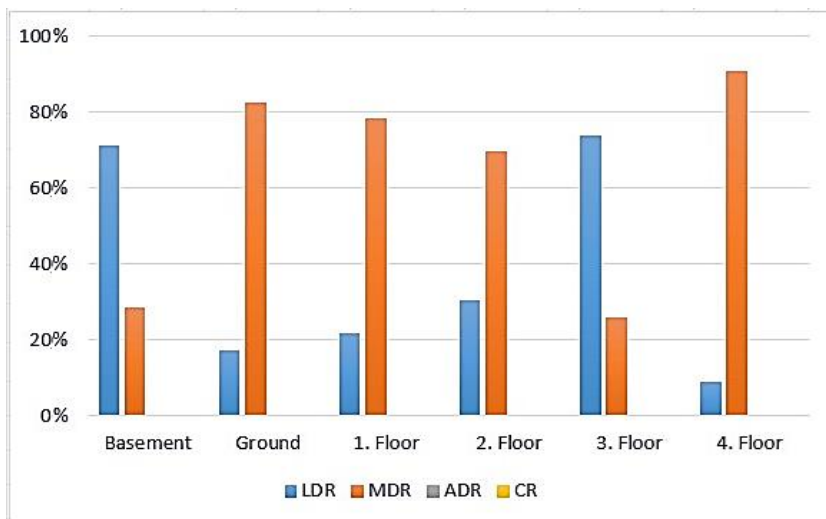
To visually present the damage states occurring in each direction, the percentage distribution of damage regions for the structural system elements on each floor is shown in Figs. 13–16.

Fig. 13. Damage distributions of vertical elements in x direction.

Fig. 14. Damage distributions of beams in x direction.

Fig. 15. Damage distributions of vertical elements in y direction.

Fig. 16. Damage distributions of beams in y direction.

The structural safety of the existing reinforced concrete building is determined based on the damage states of its vertical and horizontal load-bearing elements. As a result of the analyses, the fourth floor i.e., the roof level, where the lowest stiffness is observed and changes in column dimensions occur, has been identified as the most critical story in terms of performance level. For the Design Earthquake Level 2 (DD2), the building is expected to meet the performance target of life safety. This performance level corresponds to a state where the structural elements sustain damage that is not excessively severe and, in most cases, repairable. According to
