Case Study

Structural performance of URM school buildings during the 2019 Albania earthquakes

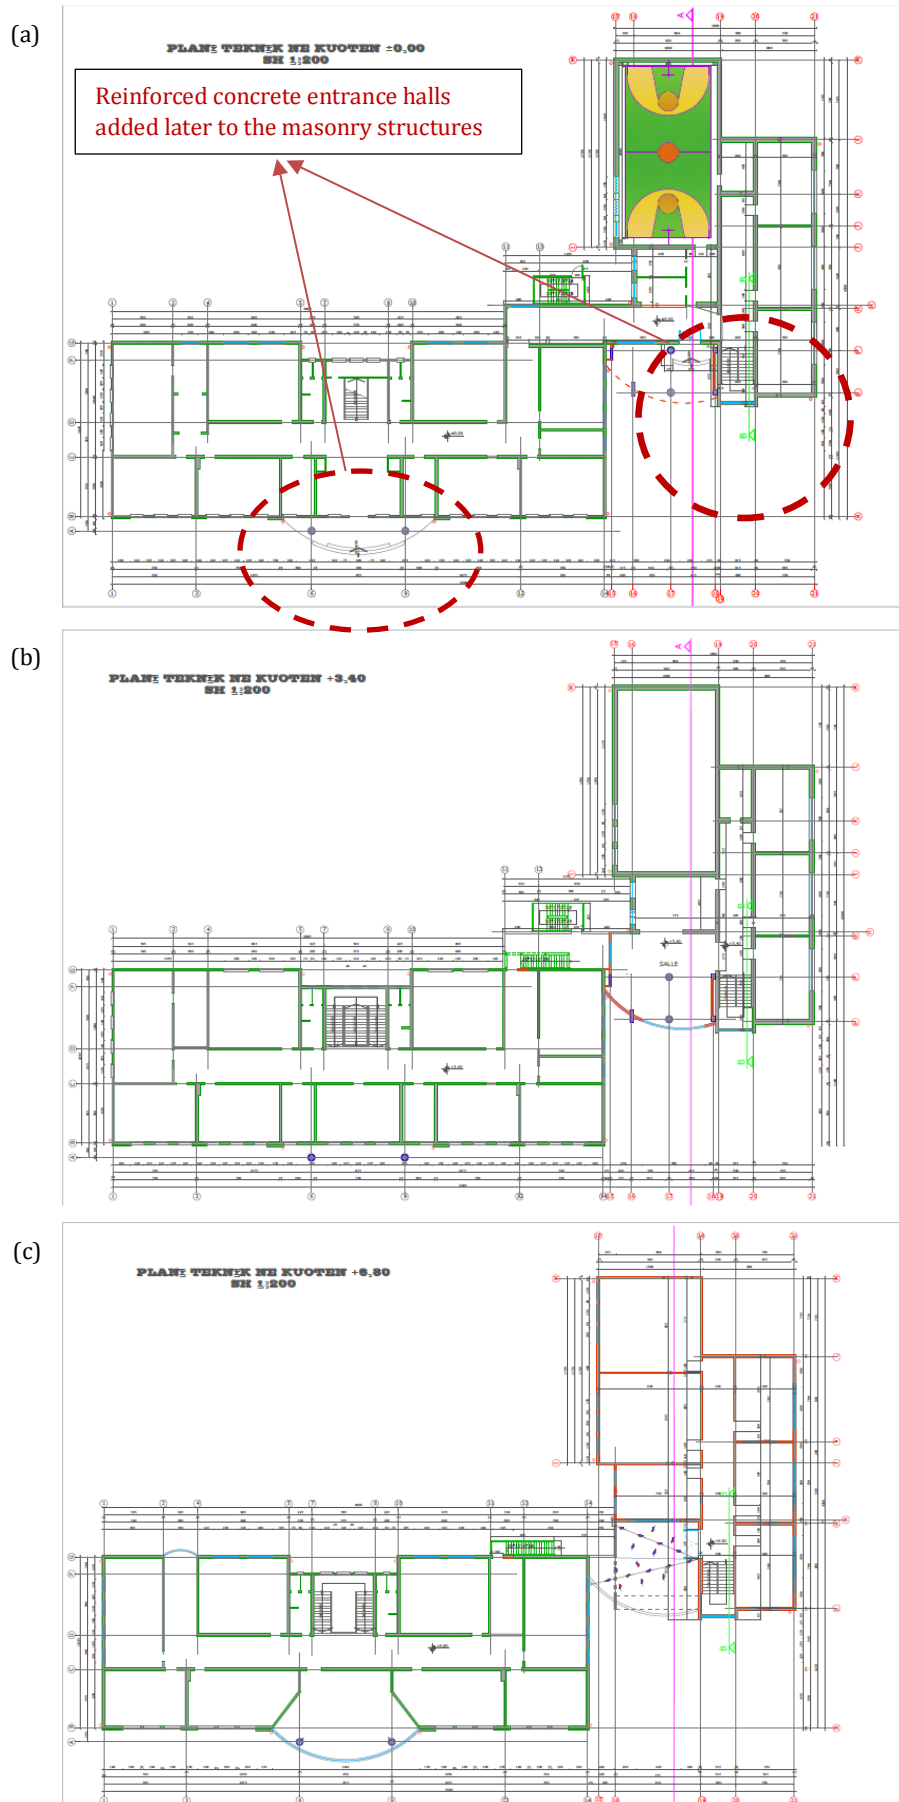
Fig. 9. a) Structural layout of Block A and B (ground floor), Reinforced concrete entrance halls added later to the masonry structures (shown by dashed red circles); b) Structural layout of Block A and B (1st floor); c) Structural layout of Block A and B (2nd floor).

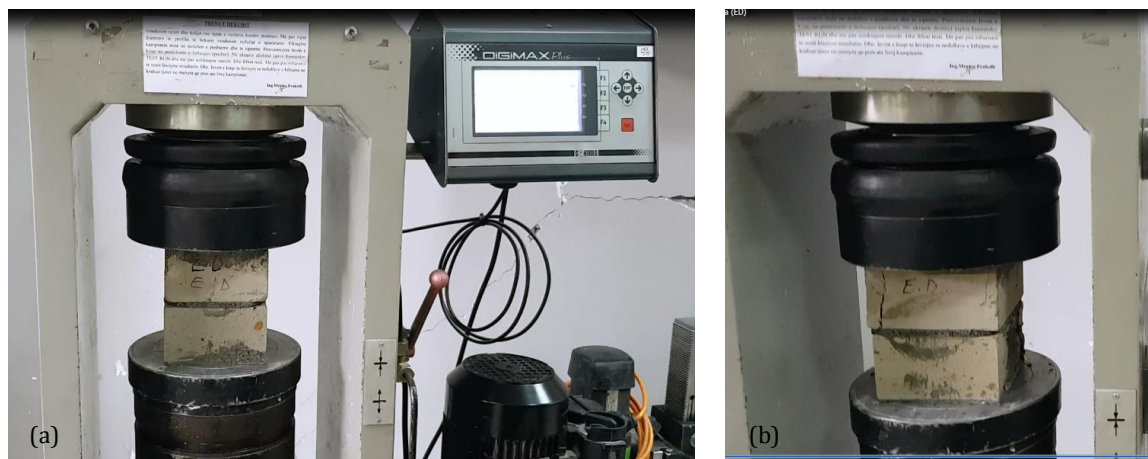
Fig. 14. a) Sample during testing; b) Sample after testing.

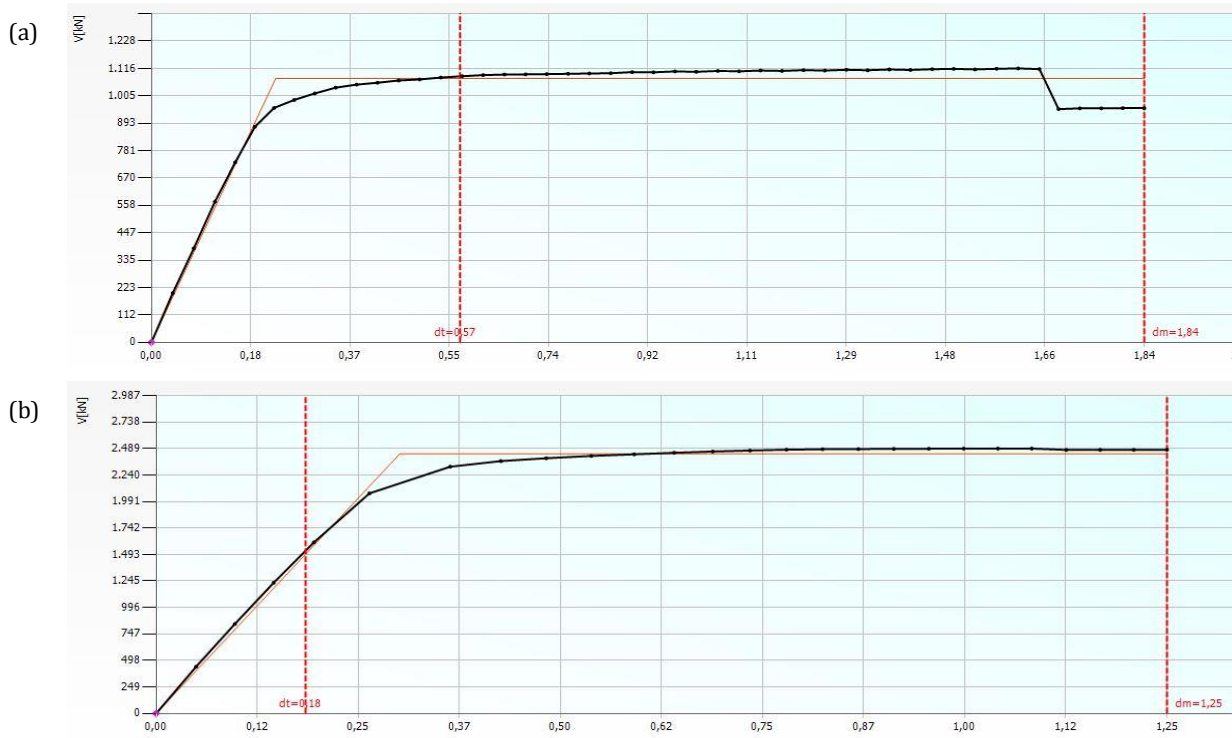
The building is pushed by 24 different loading cases and the pushover curves are plotted for the most critical loading pattern (Fig. 17).

Fig. 17. Pushover curves of B Block_2-Story: a) x- direction; b) y- direction.

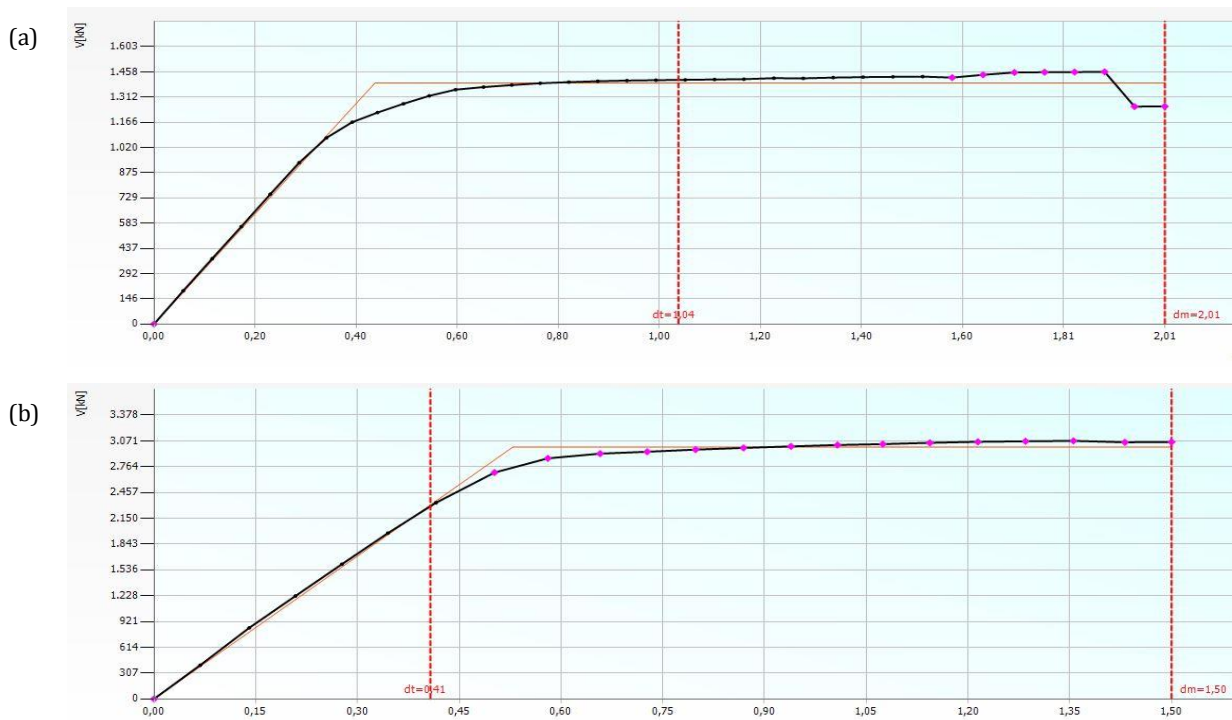
The building is pushed by 24 different loading cases and the pushover curves are plotted for the most critical loading patterns (Fig. 18).

than the 2- story design. Pushover analyses results and the damage patterns observed during the damage inspection confirms the induced damage patterns during the November 26, 2019 earthquake.

Fig. 18. Pushover curves of B Block_3-Story: a) x- direction; b) y- direction.

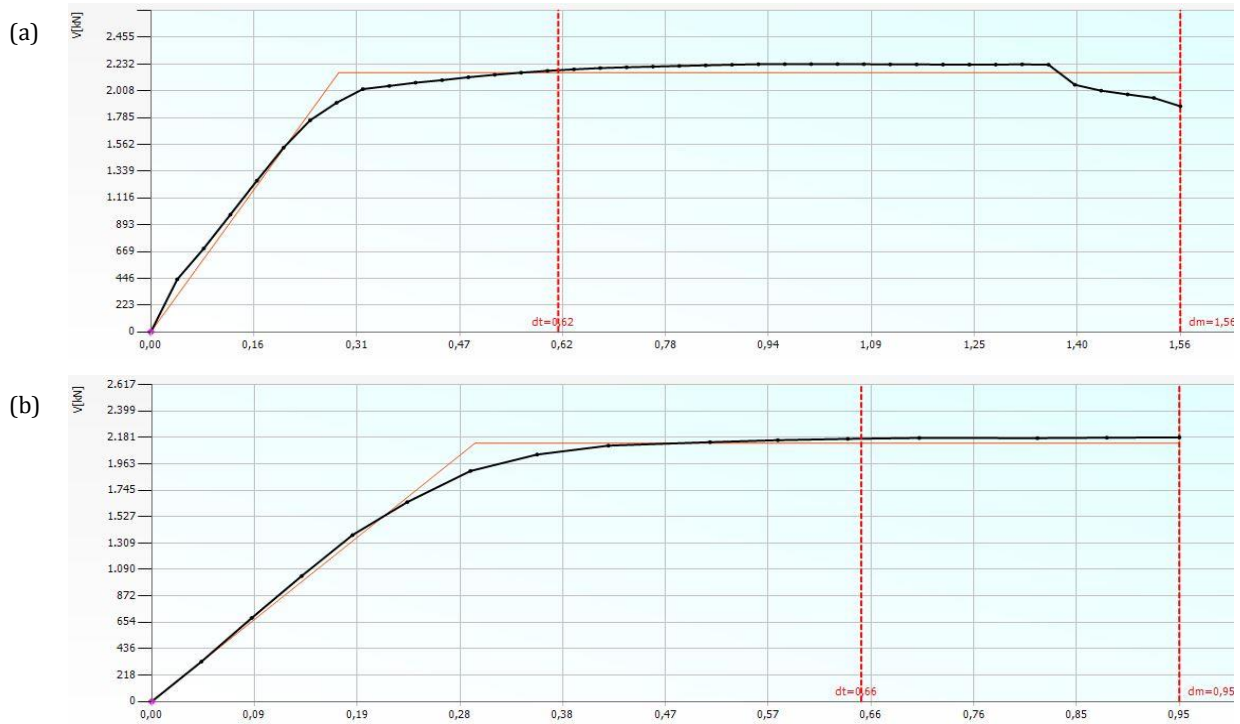
The building is pushed by 24 different loading cases and the pushover curves are plotted for the most critical loading pattern (Fig. 19).

Fig. 19. Pushover curves of A Block_2-Story: a) x- direction; b) y- direction.

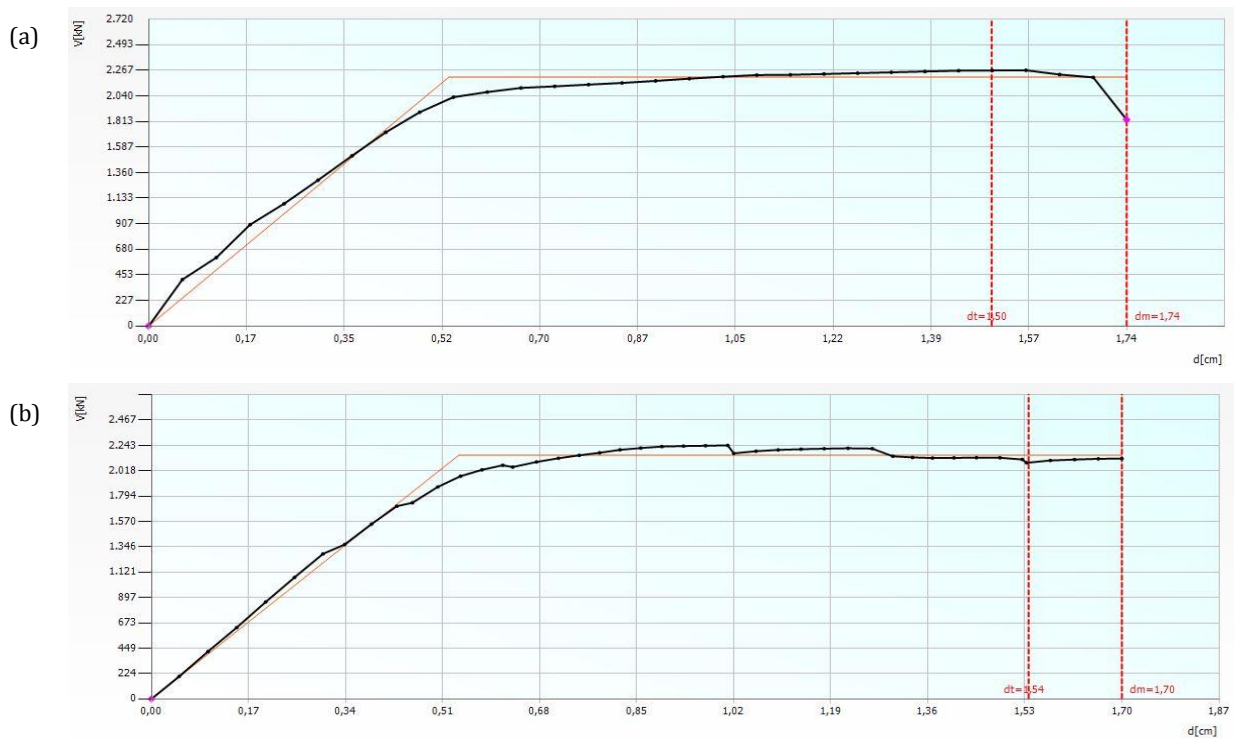
The building is pushed by 24 different loading cases and the pushover curves are plotted for the most critical loading pattern (Fig. 20).

Similar to the Block B vulnerability, addition of one story caused a reduction in the seismic resistance of Block A. This reduction in seismic resistance (around 30%) can easily be observed from the comparisons PGA values.

Fig. 20. Pushover curves of A Block_3-Story: a) x- direction; b) y- direction.
